# Access Compliance Report

## Public Rights-of-Way

### (Curb Ramps)

Intersection ID: 17134	Main Street: CODDINGTON_PL	Cross Street: RANDOLPH_RD	Location: SE
ADA ID: B915F0937B30	Ramp Type: PerpDiag	Initial Pass/Fail: Fail	Overall Compliance: No
Severity Score: 12.5			
Codes/Mitigation Info/Possible Solution		Field Measurements/Component Compliance

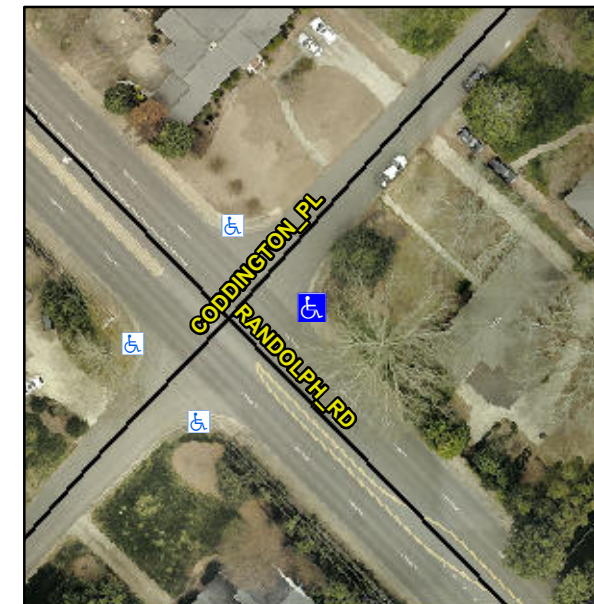
**Not Found, R304.2.2**

Compliance	Description	Data	Compliance	Description	Data
N/A	Ramp Length (in)	48.0	No	Ramp Slope (%)	9.2
Yes	Ramp Width (in)	48.0	Yes	Ramp XSlope (%)	0.5
N/A	Flare Type LT	N/A	N/A	Flare Type RT	N/A
N/A	Flare Slope LT (%)	N/A	N/A	Flare Slope RT (%)	N/A
N/A	Flare Traversable LT?	N/A	N/A	Flare Traversable RT?	N/A
N/A	Landing Length (in)	N/A	N/A	DWS Provided?	N/A
N/A	Landing Width (in)	N/A	N/A	DWS Contrast?	N/A
N/A	Landing Slope (%)	N/A	N/A	DWS Length (in)	N/A
N/A	Landing X Slope (%)	N/A	N/A	DWS Full Width?	N/A
N/A	Landing Curb? (Y/N)	N/A	N/A	DWS Offset (in)	N/A
N/A	Shared Landing?	N/A			
N/A	Gutter Ponding?	N/A	N/A	Gutter Slope (%)	N/A
N/A	Gutter Lip Ht (in)	N/A	N/A	Gutter X Slope (%)	N/A
N/A	Painted X Walk1?	No	N/A	Painted X Walk2?	No
	X Walk 1 Direction	To NW		X Walk 2 Direction	To SW
N/A	X Walk 1 Width (in)	N/A	N/A	X Walk 2 Width (in)	N/A
	X Walk 1 Slope (%)	1.6		X Walk 2 Slope (%)	4.5
	X Walk 1 X Slope (%)	3.7		X Walk 2 X Slope (%)	1.8

N/A	Ramp inside XWalk1?	N/A	N/A	Ramp inside XWalk2?	N/A
	Road Slope (%)	1.9	N/A	Clear Space?	N/A
	Road X Slope (%)	5.4	N/A	Clear Space to XWalk (in)	N/A
N/A	Any Obstructions?	N/A	N/A	Storm Grate/Utility Hazard?	N/A
	Obstruction Type			Storm Grate/Utility Type	
		N/A			N/A
			Yes	Surface Condition? (G/P)	Good

**Remove & Replace Curb Ramp With Two New Directional Ramps or Equivalent.**
