# Access Compliance Report

## Public Rights-of-Way

### (Curb Ramps)

Intersection ID: 9709	Main Street: PARK_LN	Cross Street: TUCKASEEGEE_RD	Location:	E
ADA ID: B91CDF212988	Ramp Type: Directional1	Initial Pass/Fail: Fail	Overall Compliance: No	Severity Score: 22.5

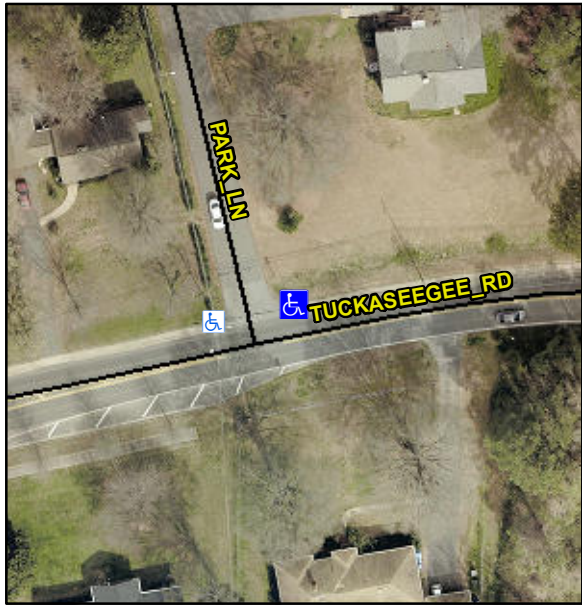
<b>N/A</b>	Landing Slope (%)		<b>0.0</b>	<b>N/A</b>	DWS Length (in)		<b>N/A</b>		
			<b>N/A</b>	Landing X Slope (%)		<b>0.0</b>	<b>N/A</b>	DWS Full Width?		<b>N/A</b>		
PROW/ADA:			<b>N/A</b>	Landing Curb? (Y/N)		<b>N/A</b>	<b>N/A</b>	DWS Offset LT (in)		<b>N/A</b>		
<b>R304.5.1, R304.2.2, R304.5.3</b>			<b>N/A</b>	Shared Landing?		<b>N/A</b>	<b>N/A</b>	DWS Offset RT (in)		<b>N/A</b>		
			<b>N/A</b>	Gutter Ponding?		<b>0.0</b>	<b>N/A</b>	Gutter Slope (%)		<b>N/A</b>		
			<b>N/A</b>	Gutter Lip Ht (in)		<b>0.0</b>	<b>N/A</b>	Gutter X Slope (%)		<b>N/A</b>		
			<b>N/A</b>	Painted X Walk1?		<b>No</b>		Road Slope (%)		<b>2.6</b>		
				X Walk 1 Direction		<b>To W</b>		Road X Slope (%)		<b>4.6</b>		
				X Walk 1 Width (in)		<b>N/A</b>		Clear Space?		<b>N/A</b>		
				X Walk 1 Slope (%)		<b>2.6</b>	<b>N/A</b>	Clear Space to XWalk (in)		<b>N/A</b>		
				X Walk 1 X Slope (%)		<b>4.6</b>	<b>N/A</b>	Storm Grate/Utility Hazard?		<b>N/A</b>

<b>N/A</b>	Ramp inside XWalk1?		<b>N/A</b>		Storm Grate/Utility Type				
			<b>N/A</b>	Any Obstructions?		<b>N/A</b>				<b>N/A</b>		
				Obstruction Type			<b>Yes</b>	Surface Condition? (G/P)		<b>Good</b>		
						<b>N/A</b>	<b>N/A</b>	Curb Slope (%)		<b>0.1</b>		
Street 1 Name		<b>PARK LN</b>										
Stop Condition-Street 1		<b>StopSign</b>										
Street 2 Name		<b>N/A</b>										
Stop Condition-Street 2		<b>N/A</b>										
Total Cost:		<b>\$ 1600.00</b>

Possible Solutions:		<b>Compliance</b>			<b>Description</b>			<b>Data</b>			
	<b>Remove &amp; Replace Entire Ramp.</b>		<b>N/A</b>	Ramp Length (in)		<b>86.5</b>	<b>N/A</b>	Grade Break?		<b>N/A</b>		
			<b>No</b>	Ramp Width (in)		<b>37.0</b>	<b>N/A</b>	Grade Break Slope (%)		<b>0.0</b>		
			<b>No</b>	Ramp Slope (%)		<b>11.5</b>	<b>N/A</b>	Grade Break XSlope (%)		<b>0.0</b>		
			<b>No</b>	Ramp XSlope (%)		<b>2.1</b>						
			<b>N/A</b>	Flare Type LT		<b>N/A</b>	<b>N/A</b>	Flare Type RT		<b>N/A</b>		
			<b>N/A</b>	Flare Slope LT (%)		<b>N/A</b>	<b>N/A</b>	Flare Slope RT (%)		<b>0.0</b>		
			<b>N/A</b>	Flare Traversable LT?		<b>N/A</b>	<b>N/A</b>	Flare Traversable RT?		<b>N/A</b>		
	Surveyor Notes:		<b>N/A</b>	<b>N/A</b>	Landing Length (in)		<b>0.0</b>	<b>N/A</b>	DWS Provided?		<b>N/A</b>	
				<b>N/A</b>	Landing Width (in)		<b>0.0</b>	<b>N/A</b>	DWS Contrast?		<b>N/A</b>
