Access Compliance Report

Public Rights-of-Way

(Curb Ramps)

Intersection ID: 11717	Main Street: E_15TH_ST	Cross Street: N_DAVIDSON_ST	Location: E
ADA ID: B923DC586CE3	Ramp Type: PerpDiag	Initial Pass/Fail: Fail	Overall Compliance: No
		Severity Score: 8.75

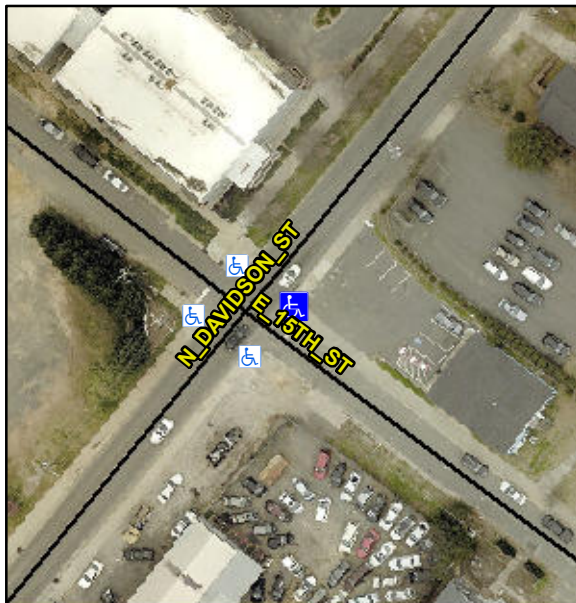
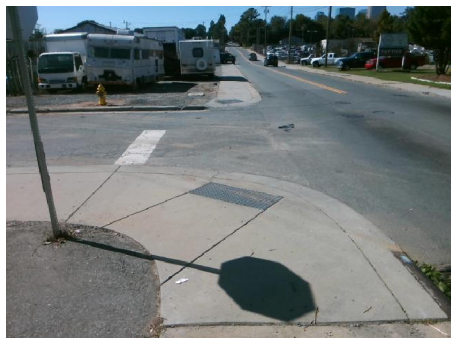
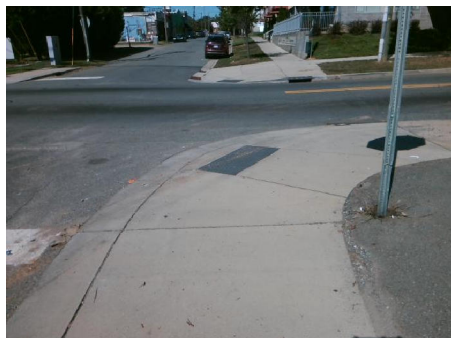
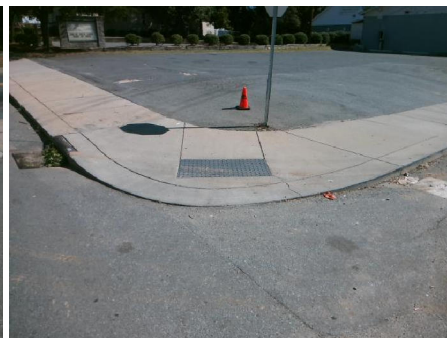
Not Found, R304.5.1

Compliance	Description	Data	Compliance	Description	Data
N/A	Ramp Length (in)	87.0	Yes	Ramp Slope (%)	6.2
No	Ramp Width (in)	47.5	Yes	Ramp XSlope (%)	1.8
N/A	Flare Type LT	N/A	N/A	Flare Type RT	N/A
N/A	Flare Slope LT (%)	N/A	N/A	Flare Slope RT (%)	N/A
N/A	Flare Traversable LT?	N/A	N/A	Flare Traversable RT?	N/A
N/A	Landing Length (in)	N/A	N/A	DWS Provided?	N/A
N/A	Landing Width (in)	N/A	N/A	DWS Contrast?	N/A
N/A	Landing Slope (%)	N/A	N/A	DWS Length (in)	N/A
N/A	Landing X Slope (%)	N/A	N/A	DWS Full Width?	N/A
N/A	Landing Curb? (Y/N)	N/A	N/A	DWS Offset (in)	N/A
N/A	Shared Landing?	N/A			
N/A	Gutter Ponding?	N/A	N/A	Gutter Slope (%)	N/A
N/A	Gutter Lip Ht (in)	N/A	N/A	Gutter X Slope (%)	N/A
N/A	Painted X Walk1?	No	N/A	Painted X Walk2?	No
	X Walk 1 Direction	To NW		X Walk 2 Direction	To SW
N/A	X Walk 1 Width (in)	N/A	N/A	X Walk 2 Width (in)	N/A
	X Walk 1 Slope (%)	4.6		X Walk 2 Slope (%)	1.7
	X Walk 1 X Slope (%)	0.5		X Walk 2 X Slope (%)	2.3

N/A	Ramp inside XWalk1?	N/A	N/A	Ramp inside XWalk2?	N/A
	Road Slope (%)	1.4	N/A	Clear Space?	N/A
	Road X Slope (%)	0.1	N/A	Clear Space to XWalk (in)	N/A
N/A	Any Obstructions?	N/A	N/A	Storm Grate/Utility Hazard?	N/A
	Obstruction Type			Storm Grate/Utility Type	
		N/A			N/A
		Yes		Surface Condition? (G/P)	Good

Remove & Replace Curb Ramp With Two New Directional Ramps or Equivalent.
