## Access Compliance Report Public Rights-of-Way (Curb Ramps)

Intersection ID: 26984	Main Street: DAIRY_CT			Street:	RED_MAPLE_DR	Location:	SE		
ADA ID: B929C46C4FD5	Ramp Type: PerpDiag			Initial Pass/Fail: Fail Overall Compliance: No				o Severity Score:	42.5
Codes/Mitigation Info/Possible Solution				Field Measurements/Component Compliance					
	2 W 2 m 2	Possible Solutions:		Compliance Description Date			a Compliance Description Data		
	Sales -	Remove & Replace Curb Ramp	Nith	N/A	Ramp Length (in)	94.5	No	Ramp Slope (%)	8.9
		Two New Directional Ramps or		No	Ramp Width (in)	33.0	No	Ramp XSlope (%)	5.4
		Equivalent.		N/A	Flare Type LT	N/A	N/A	Flare Type RT	N/A
				N/A	Flare Slope LT (%)	N/A	N/A	Flare Slope RT (%)	N/A
				N/A	Flare Traversable LT?	N/A	N/A	Flare Traversable RT?	N/A
				N/A	Landing Length (in)	N/A	N/A	DWS Provided?	N/A
		Surveyor Notes:		N/A	Landing Width (in)	N/A	N/A	DWS Contrast?	N/A
E C		N/A		N/A	Landing Slope (%)	N/A	N/A	DWS Length (in)	N/A
				N/A	Landing X Slope (%)	N/A	N/A	DWS Full Width?	N/A

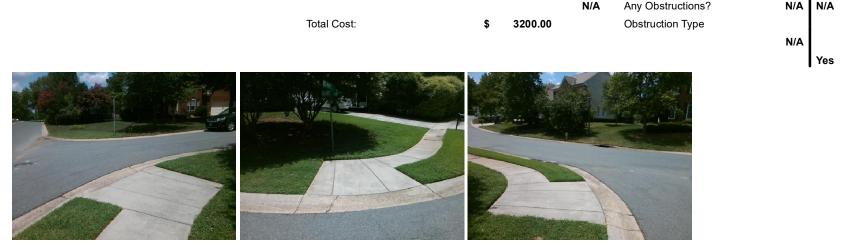
N/A	Landing Curb? (Y/N)	N/A	N/A	DWS Offset (in)	N/A
3C ALF I	0			N/A	Shared Landing?	N/A			
	And and the state	PROW/ADA:		N/A	Gutter Ponding?	N/A	N/A	Gutter Slope (%)	N/A
R304.5.1, R304.2.2, R304.5.3				N/A	Gutter Lip Ht (in)	N/A	N/A	Gutter X Slope (%)	N/A
				N/A	Painted X Walk1?	No	N/A	Painted X Walk2?	No
				X Walk 1 Direction	To NW		X Walk 2 Direction	To W	
and the second second			N/A	X Walk 1 Width (in)	N/A	N/A	X Walk 2 Width (in)	N/A	
Street 1 Name	DAIRY CT	-			X Walk 1 Slope (%)	1.9		X Walk 2 Slope (%)	2.6
Stop Condition-Street 2	StopSign				X Walk 1 X Slope (%)	3.0		X Walk 2 X Slope (%)	3.1
Street 2 Name	RED MAPLE DR			N/A	Ramp inside XWalk1?	N/A	N/A	Ramp inside XWalk2?	N/A
Stop Condition-Street 1	None				Road Slope (%)	3.6	N/A	Clear Space?	N/A
					Road X Slope (%)	0.0	N/A	Clear Space to XWalk (in)	N/A
				N/A	Any Obstructions?	0.0 N/A	N/A	Storm Grate/Utility Hazard?	N/A
		Total Cost: \$	3200.00	100	Obstruction Type	174		Storm Grate/Utility Type	N/A
