Access Compliance Report Public Rights-of-Way (Curb Ramps)

Intersection ID: 8870 Main Street: WELLS_ST Cross Street: NORRIS_AV Location: NW

ADA ID: B93422E7939C Ramp Type: Perp Initial Pass/Fail: Fail Overall Compliance: No Severity Score: 22.5

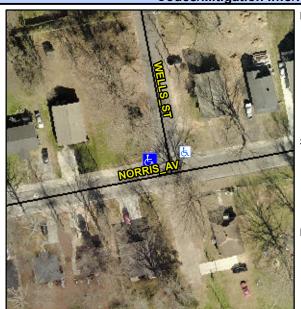
Street 1 Name WELLS ST
Stop Condition-Street 2 StopSign
Street 2 Name N/A
Stop Condition-Street 1 N/A

Not Found, R304.5.1, R304.2.2, R304.5.3

Remove & Replace Entire Ramp.
