Access Compliance Report Public Rights-of-Way (Curb Ramps)

Intersection ID: 10040093 Main Street: TUCKASEEGEE_RD Cross Street: N/A Location: **Overall Compliance: No** ADA ID: B936B5686882 Ramp Type: Perp Initial Pass/Fail: Fail Severity Score: 33.75

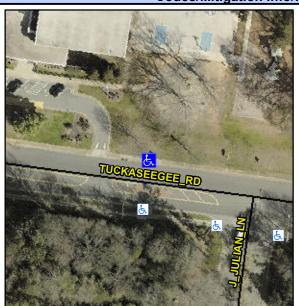
Field Measurements/Component Compliance								
Comp	liance Description	Data	Comp	liance Description	Data			
N/A	Ramp Length (in)	49.0	No	Ramp Slope (%)	13.2			
No	Ramp Width (in)	47.5	Yes	Ramp XSlope (%)	0.9			
N/A	Flare Type LT	N/A	N/A	Flare Type RT	N/A			
N/A	Flare Slope LT (%)	N/A	N/A	Flare Slope RT (%)	N/A			
N/A	Flare Traversable LT?	N/A	N/A	Flare Traversable RT?	N/A			
N/A	Landing Length (in)	N/A	N/A	DWS Provided?	N/A			
N/A	Landing Width (in)	N/A	N/A	DWS Contrast?	N/A			
N/A	Landing Slope (%)	N/A	N/A	DWS Length (in)	N/A			
N/A	Landing X Slope (%)	N/A	N/A	DWS Full Width?	N/A			
N/A	Landing Curb? (Y/N)	N/A	N/A	DWS Offset (in)	N/A			
N/A	Shared Landing?	N/A						
N/A	Gutter Ponding?	N/A	N/A	Gutter Slope (%)	N/A			
N/A	Gutter Lip Ht (in)	N/A	N/A	Gutter X Slope (%)	N/A			
N/A	Painted X Walk1?	No	N/A	Painted X Walk2?	N/A			
	X Walk 1 Direction	To S		X Walk 2 Direction	N/A			
N/A	X Walk 1 Width (in)	N/A	N/A	X Walk 2 Width (in)	N/A

X Walk 1 Slope (%)	4.5		X Walk 2 Slope (%)	N/A			
	X Walk 1 X Slope (%)	1.2		X Walk 2 X Slope (%)	N/A			
N/A	Ramp inside XWalk1?	N/A	N/A	Ramp inside XWalk2?	N/A			
	Road Slope (%)	N/A	N/A	Clear Space?	N/A			
	Road X Slope (%)	N/A	N/A	Clear Space to XWalk (in)	N/A			
N/A	Any Obstructions?	N/A	N/A	Storm Grate/Utility Hazard?	N/A			
	Obstruction Type			Storm Grate/Utility Type				
		N/A			N/A			
			Yes	Surface Condition? (G/P)	Good			
2000

Possible Solutions:						
Remove & Replace Entire Ramp.						
·						
Surveyor Notes:						
N/A						
N/A						
PROW/ADA:						
Not Found, R304.5.1, R304.2.2
