Access Compliance Report Public Rights-of-Way (Curb Ramps)

Intersection ID: 19543 Main Street: SCOFIELD_RD Cross Street: TOPPING_PL Location:

ADA ID: B94738B5B1FA Ramp Type: ParaDiag Initial Pass/Fail: Fail Overall Compliance: No Severity Score: 48.75

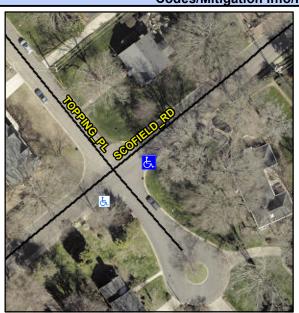
Field Measure Compliance Description		Data	Comp	oliance Description	Data
N/A	Ramp Length LT (in)	44.0	N/A	Ramp Length RT (in)	43.0
Yes	Ramp Width LT (in)	52.0	No	Ramp Width RT (in)	28.0
No	Ramp Slope LT (%)	10.8	Yes	Ramp Slope RT (%)	8.2
No	Ramp XSlope LT (%)	2.8	Yes	Ramp XSlope RT (%)	0.5
N/A	Landing Length (in)	N/A	N/A	DWS Provided?	N/A
N/A	Landing Width (in)	N/A	N/A	DWS Contrast?	N/A
N/A	Landing Slope (%)	N/A	N/A	DWS Length (in)	N/A
N/A	Landing X Slope (%)	N/A	N/A	DWS Full Width?	N/A
N/A	Landing Curb? (Y/N)	N/A	N/A	DWS Offset (in)	N/A
N/A	Shared Landing?	N/A			
N/A	Gutter Ponding?	N/A	N/A	Gutter Slope (%)	N/A
N/A	Gutter Lip Ht (in)	N/A	N/A	Gutter X Slope (%)	N/A
N/A	Painted X Walk1?	No	N/A	Painted X Walk2?	No
	X Walk 1 Direction	To NW		X Walk 2 Direction	To SW
N/A	X Walk 1 Width (in)	N/A	N/A	X Walk 2 Width (in)	N/A
	X Walk 1 Slope (%)	3.6		X Walk 2 Slope (%)	5.2
	X Walk 1 X Slope (%)	7.1		X Walk 2 X Slope (%)	9.7

N/A	Ramp inside XWalk1?	N/A	N/A	Ramp inside XWalk2?	N/A
	Road Slope (%)	9.1	N/A	Clear Space?	N/A
	Road X Slope (%)	3.8	N/A	Clear Space to XWalk (in)	N/A
N/A	Any Obstructions?	N/A	N/A	Storm Grate/Utility Hazard?	N/A
	Obstruction Type			Storm Grate/Utility Type	
		N/A			N/A
			Yes	Surface Condition? (G/P)	Good
			N/A	Curb Slope (%)	0.7

SCOFIELD RD None TOPPING PL StopSign Possible Solutions:

Remove & Replace Curb Ramp With Two New Directional Ramps or Equivalent.

R304.5.1, R304.3.2, R304.5.3
