# Access Compliance Report

## Public Rights-of-Way

| Intersection ID: 23044 | Main Street: CARMEL_RD | Cross Street: CROSSGATE_RD | Location: | N |
| ADA ID: B94B811C3BB6 | Ramp Type: PerpDiag | Initial Pass/Fail: Fail | Overall Compliance: No | Severity Score: 13.75 |

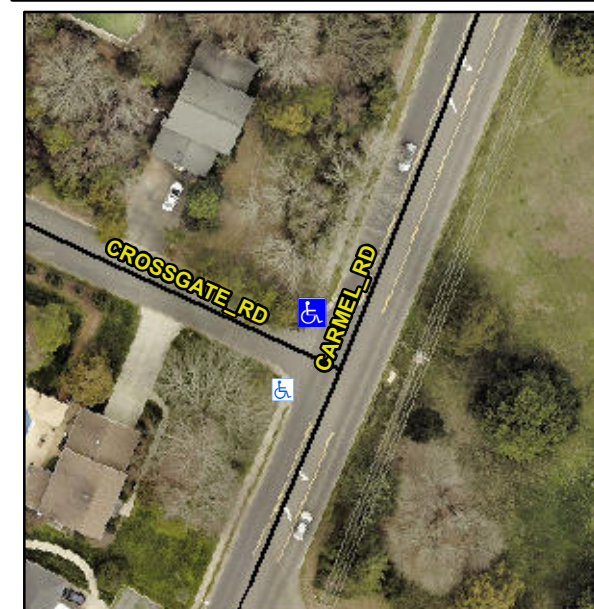
**Not Found, R304.2.2, R304.5.3**

| Compliance | Description | Data | Compliance | Description | Data |
|---|---|---|---|---|---|
| N/A | Ramp Length (in) | 58.0 | No | Ramp Slope (%) | 8.9 |
| Yes | Ramp Width (in) | 48.0 | No | Ramp XSlope (%) | 2.6 |

**Remove & Replace Curb Ramp With Two New Directional Ramps or Equivalent.**
