Intersection ID: 18795	Main Street: LAMONT_DR	Cross Street: SENECA_PL	Location:	SW
ADA ID: B954470C3062	Ramp Type: Perp	Initial Pass/Fail: Fail	Overall Compliance: No	Severity Score: 12.5

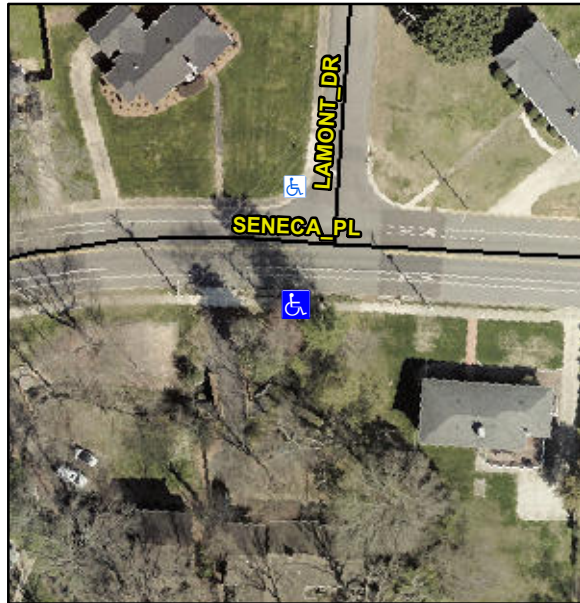
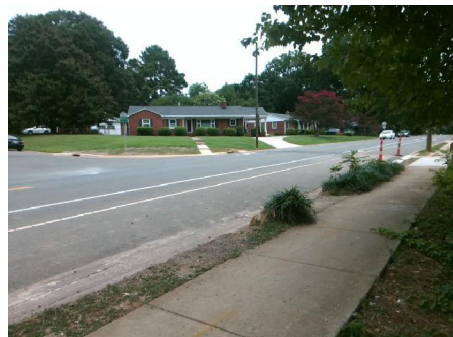
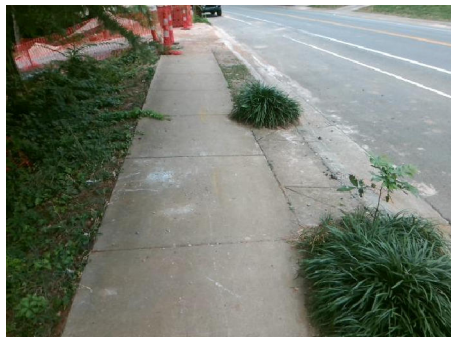
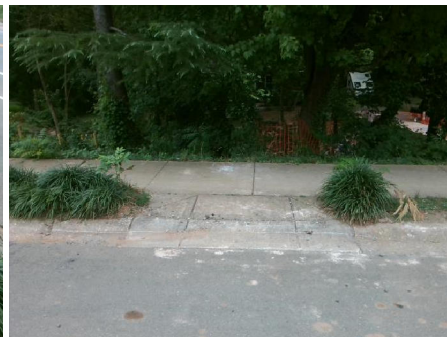
Not Found, R304.2.2

Compliance	Description	Data	Compliance	Description	Data
N/A	Ramp Length (in)	25.0	No	Ramp Slope (%)	9.7
Yes	Ramp Width (in)	48.0	Yes	Ramp XSlope (%)	1.6
N/A	Flare Type LT	N/A	N/A	Flare Type RT	N/A
N/A	Flare Slope LT (%)	N/A	N/A	Flare Slope RT (%)	N/A
N/A	Flare Traversable LT?	N/A	N/A	Flare Traversable RT?	N/A
N/A	Landing Length (in)	N/A	N/A	DWS Provided?	N/A
N/A	Landing Width (in)	N/A	N/A	DWS Contrast?	N/A
N/A	Landing Slope (%)	N/A	N/A	DWS Length (in)	N/A
N/A	Landing X Slope (%)	N/A	N/A	DWS Full Width?	N/A
N/A	Landing Curb? (Y/N)	N/A	N/A	DWS Offset (in)	N/A
N/A	Shared Landing?	N/A			
N/A	Gutter Ponding?	N/A	N/A	Gutter Slope (%)	N/A
N/A	Gutter Lip Ht (in)	N/A	N/A	Gutter X Slope (%)	N/A
N/A	Painted X Walk1?	No	N/A	Painted X Walk2?	N/A
	X Walk 1 Direction	To N		X Walk 2 Direction	N/A
N/A	X Walk 1 Width (in)	N/A	N/A	X Walk 2 Width (in)	N/A
	X Walk 1 Slope (%)	7.3		X Walk 2 Slope (%)	N/A
	X Walk 1 X Slope (%)	1.1		X Walk 2 X Slope (%)	N/A

N/A	Ramp inside XWalk1?	N/A	N/A	Ramp inside XWalk2?	N/A
	Road Slope (%)	N/A	N/A	Clear Space?	N/A
	Road X Slope (%)	N/A	N/A	Clear Space to XWalk (in)	N/A
N/A	Any Obstructions?	N/A	N/A	Storm Grate/Utility Hazard?	N/A
	Obstruction Type			Storm Grate/Utility Type	
		N/A			N/A
			Yes	Surface Condition? (G/P)	Good

Remove & Replace Entire Ramp.

Total Cost: \$ 1850.00
