## Access Compliance Report Public Rights-of-Way (Curb Ramps)

0.11/
Intersection ID: 43710 Main Street: OLDE_ENGLISH_DR			Cross Street: PHEASANT_CHASE_LN					Location:	SW	
ADA ID: B956B46D8CA9 Ramp Type: Perp			Initial Pass/Fail: Fail Overall Compliance: No					o Severity Score:	21.25	
Codes/Mitigation Info/Possible Solution			Field Measurements/Component Compliance							
	1 × 1 ×	Possible Solutions:		Compliance Description			Data	Data Compliance Description		Data
	William Kome	Remove & Replace E	ntire Ramp.	N/A	Ramp	Length (in)	48.0	Yes	Ramp Slope (%)	7.2
				No	Ramp	Width (in)	46.5	No	Ramp XSlope (%)	6.3
				N/A	Flare	Type LT	N/A	N/A	Flare Type RT	N/A
				N/A	Flare	Slope LT (%)	N/A	N/A	Flare Slope RT (%)	N/A
			N/A	Flare	Traversable LT?	N/A	N/A	Flare Traversable RT?	N/A	
ANGUSH DR	1		N/A	Landin	ig Length (in)	N/A	N/A	DWS Provided?	N/A

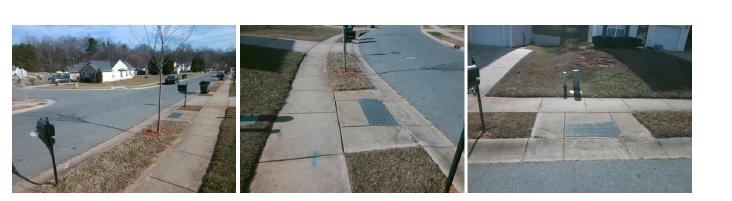
- La fame	Surveyor Notes:		N/A	Landin	ıg Width (in)	N/A	N/A	DWS Contrast?	N/A
the second se	N/A		N/A	Landin	ig Slope (%)	N/A	N/A	DWS Length (in)	N/A	
			N/A	Landin	ig X Slope (%)	N/A	N/A	DWS Full Width?	N/A	
				N/A	Landin	ig Curb? (Y/N)	N/A	N/A	DWS Offset (in)	N/A
	and minister			N/A	Share	d Landing?	N/A			
the second second second		PROW/ADA:		N/A	Gutter	Ponding?	N/A	N/A	Gutter Slope (%)	N/A
Not Found, R304.5.1, R304.5.3			N/A	Gutter	Lip Ht (in)	N/A	N/A	Gutter X Slope (%)	N/A	
	1 - 1 - A.			N/A	Painte	d X Walk1?	No	N/A	Painted X Walk2?	N/A
e e				X Wall	A 1 Direction	To NW		X Walk 2 Direction	N/A	
			N/A	X Wall	c 1 Width (in)	N/A	N/A	X Walk 2 Width (in)	N/A	
Street 1 Name OLD	E ENGLISH DR				X Wall	( 1 Slope (%)	2.5		X Walk 2 Slope (%)	N/A
Stop Condition-Street 2	None				X Wall	<pre>x 1 X Slope (%)</pre>	5.4		X Walk 2 X Slope (%)	N/A
Street 2 Name	N/A			N/A	Ramp	inside XWalk1?	N/A	N/A	Ramp inside XWalk2?	N/A

Stop Condition-Street 1	N/A				Road	Slope (%)	N/A	N/A	Clear Space?	N/A
					Road 2	X Slope (%)	N/A	N/A	Clear Space to XWalk (in)	N/A
				N/A	Any O	bstructions?	N/A	N/A	Storm Grate/Utility Hazard?	N/A
		Total Cost:	\$ 1	850.00	Obstru	iction Type			Storm Grate/Utility Type	
							N/A			N/A
