Access Compliance Report

Public Rights-of-Way

(Curb Ramps)

Intersection ID: 31378	Main Street: CARRINGTON_HILL_DR	Cross Street: AUBREYWOOD_DR	Location: SE
ADA ID: B9570EBA9785	Ramp Type: PerpDiag	Initial Pass/Fail: Fail	Overall Compliance: No
Codes/Mitigation Info/Possible Solution		Field Measurements/Component Compliance	
Severity Score: 33.75

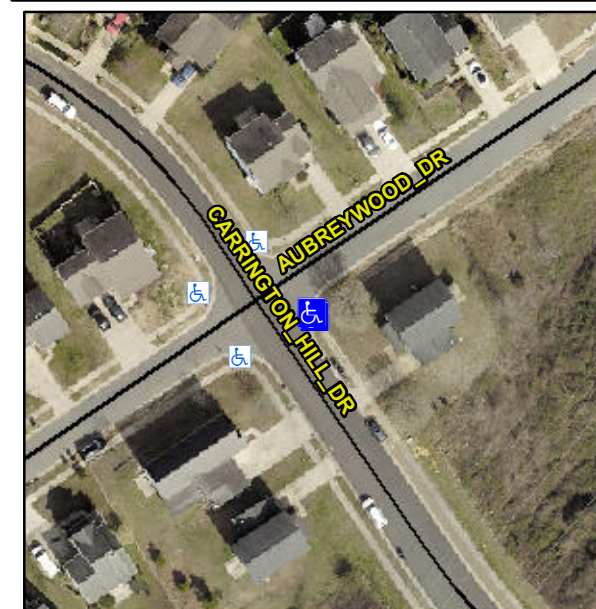
Not Found, R304.5.1, R304.2.2, R304.5.3

Compliance	Description	Data	Compliance	Description	Data
N/A	Ramp Length (in)	51.5	No	Ramp Slope (%)	11.3
No	Ramp Width (in)	40.0	No	Ramp XSlope (%)	6.3
N/A	Flare Type LT	N/A	N/A	Flare Type RT	N/A
N/A	Flare Slope LT (%)	N/A	N/A	Flare Slope RT (%)	N/A
N/A	Flare Traversable LT?	N/A	N/A	Flare Traversable RT?	N/A
N/A	Landing Length (in)	N/A	N/A	DWS Provided?	N/A
N/A	Landing Width (in)	N/A	N/A	DWS Contrast?	N/A
N/A	Landing Slope (%)	N/A	N/A	DWS Length (in)	N/A
N/A	Landing X Slope (%)	N/A	N/A	DWS Full Width?	N/A
N/A	Landing Curb? (Y/N)	N/A	N/A	DWS Offset (in)	N/A
N/A	Shared Landing?	N/A			
N/A	Gutter Ponding?	N/A	N/A	Gutter Slope (%)	N/A
N/A	Gutter Lip Ht (in)	N/A	N/A	Gutter X Slope (%)	N/A
N/A	Painted X Walk1?	No	N/A	Painted X Walk2?	No
	X Walk 1 Direction	To NW		X Walk 2 Direction	To W
N/A	X Walk 1 Width (in)	N/A	N/A	X Walk 2 Width (in)	N/A
	X Walk 1 Slope (%)	4.0		X Walk 2 Slope (%)	6.1
	X Walk 1 X Slope (%)	3.9		X Walk 2 X Slope (%)	6.0

N/A	Ramp inside XWalk1?	N/A	N/A	Ramp inside XWalk2?	N/A
	Road Slope (%)	8.7	N/A	Clear Space?	N/A
	Road X Slope (%)	1.2	N/A	Clear Space to XWalk (in)	N/A
N/A	Any Obstructions?	N/A	N/A	Storm Grate/Utility Hazard?	N/A
	Obstruction Type			Storm Grate/Utility Type	
		N/A			N/A
			Yes	Surface Condition? (G/P)	Good

Possible Solutions:

Remove & Replace Curb Ramp With Two New Directional Ramps or Equivalent.
