Access Compliance Report

Public Rights-of-Way

(Curb Ramps)

| Intersection ID: 47278 | Main Street: BERNADINE_CT | Cross Street: CARRINGTON_FOREST_LN | Location: SW |

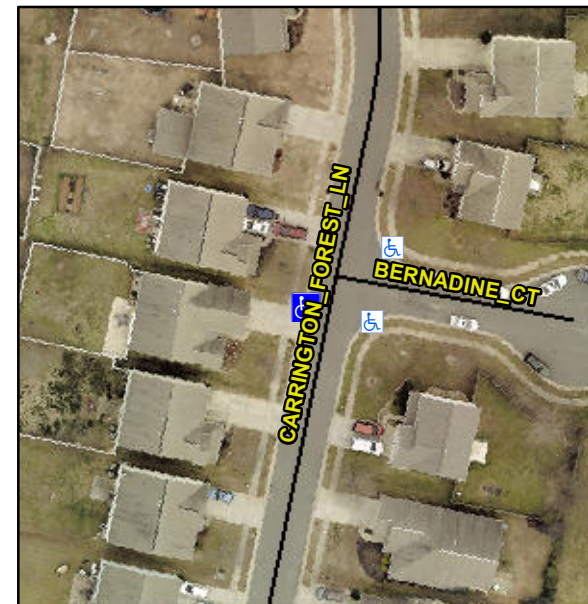
Not Found, R304.5.1, R304.5.3

| Compliance | Description | Data | Compliance | Description | Data |
|---|---|---|---|---|---|
| No | Ramp Width (in) | 35.0 | No | Ramp XSlope (%) | 3.9 |

Remove & Replace Entire Ramp.
