Access Compliance Report

Public Rights-of-Way

(Curb Ramps)

Intersection ID: 48857	Main Street: FENCELINE_DR	Cross Street: GREENFINCH_DR	Location: SE
ADA ID: B965323C1276	Ramp Type: PerpDiag	Initial Pass/Fail: Fail	Overall Compliance: No
Codes/Mitigation Info/Possible Solution		Field Measurements/Component Compliance	
Severity Score: 33.75

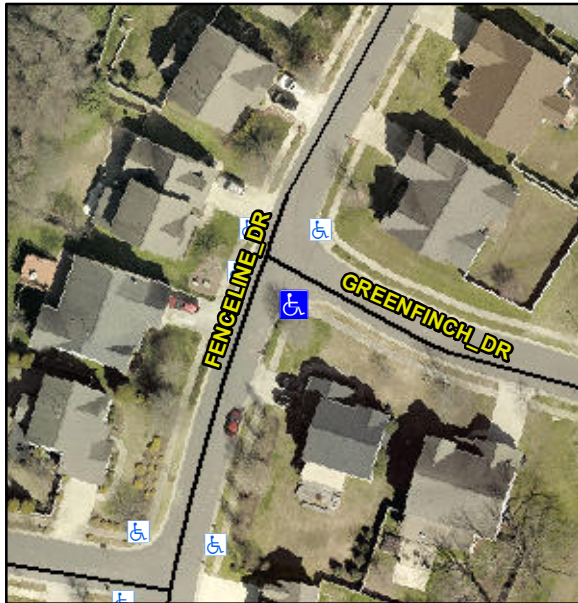
Compliance	Description	Data	Compliance	Description	Data
N/A	Ramp Length (in)	52.0	No	Ramp Slope (%)	11.6
No	Ramp Width (in)	45.0	No	Ramp XSlope (%)	5.2
N/A	Flare Type LT	N/A	N/A	Flare Type RT	N/A
N/A	Flare Slope LT (%)	N/A	N/A	Flare Slope RT (%)	N/A
N/A	Flare Traversable LT?	N/A	N/A	Flare Traversable RT?	N/A
N/A	Landing Length (in)	N/A	N/A	DWS Provided?	N/A
N/A	Landing Width (in)	N/A	N/A	DWS Contrast?	N/A
N/A	Landing Slope (%)	N/A	N/A	DWS Length (in)	N/A
N/A	Landing X Slope (%)	N/A	N/A	DWS Full Width?	N/A
N/A	Landing Curb? (Y/N)	N/A	N/A	DWS Offset (in)	N/A
N/A	Shared Landing?	N/A			
N/A	Gutter Ponding?	N/A	N/A	Gutter Slope (%)	N/A
N/A	Gutter Lip Ht (in)	N/A	N/A	Gutter X Slope (%)	N/A
N/A	Painted X Walk1?	No	N/A	Painted X Walk2?	No
	X Walk 1 Direction	To NE		X Walk 2 Direction	To NW
N/A	X Walk 1 Width (in)	N/A	N/A	X Walk 2 Width (in)	N/A
	X Walk 1 Slope (%)	0.5		X Walk 2 Slope (%)	3.2
	X Walk 1 X Slope (%)	1.5		X Walk 2 X Slope (%)	0.0

N/A	Ramp inside XWalk1?	N/A	N/A	Ramp inside XWalk2?	N/A
	Road Slope (%)	2.3	N/A	Clear Space?	N/A
	Road X Slope (%)	0.3	N/A	Clear Space to XWalk (in)	N/A
N/A	Any Obstructions?	N/A	N/A	Storm Grate/Utility Hazard?	N/A
	Obstruction Type			Storm Grate/Utility Type	
		N/A			N/A
			Yes	Surface Condition? (G/P)	Good

Possible Solutions:

Remove & Replace Curb Ramp With Two New Directional Ramps or Equivalent.
