# Access Compliance Report

## Public Rights-of-Way

### (Curb Ramps)

Intersection ID: 52716	Main Street: AGAVA_LN	Cross Street: MAIDENHAIR_CT	Location: SE
ADA ID: B96B0AEC556B	Ramp Type: Perp	Initial Pass/Fail: Fail	Overall Compliance: No
Severity Score: 1.25			
Codes/Mitigation Info/Possible Solution		Field Measurements/Component Compliance

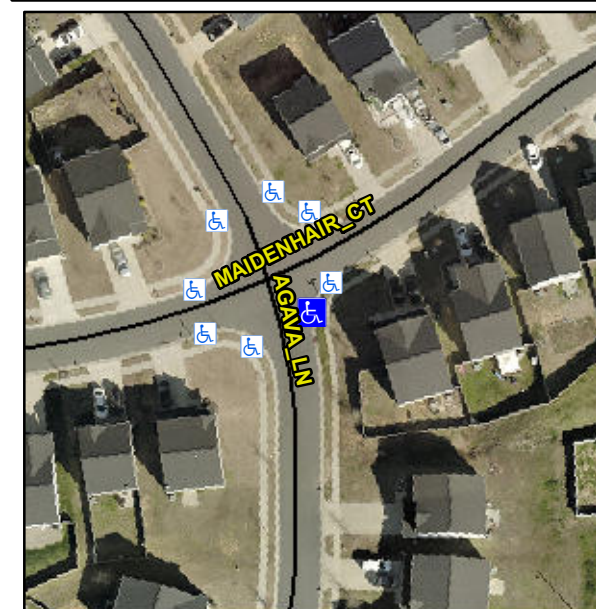
**Not Found, R304.5.3**

Compliance	Description	Data	Compliance	Description	Data
N/A	Ramp Length (in)	48.0	Yes	Ramp Slope (%)	5.5
Yes	Ramp Width (in)	48.0	No	Ramp XSlope (%)	4.6
N/A	Flare Type LT	N/A	N/A	Flare Type RT	N/A
N/A	Flare Slope LT (%)	N/A	N/A	Flare Slope RT (%)	N/A
N/A	Flare Traversable LT?	N/A	N/A	Flare Traversable RT?	N/A
N/A	Landing Length (in)	N/A	N/A	DWS Provided?	N/A
N/A	Landing Width (in)	N/A	N/A	DWS Contrast?	N/A
N/A	Landing Slope (%)	N/A	N/A	DWS Length (in)	N/A
N/A	Landing X Slope (%)	N/A	N/A	DWS Full Width?	N/A
N/A	Landing Curb? (Y/N)	N/A	N/A	DWS Offset (in)	N/A
N/A	Shared Landing?	N/A			
N/A	Gutter Ponding?	N/A	N/A	Gutter Slope (%)	N/A
N/A	Gutter Lip Ht (in)	0.5	N/A	Gutter X Slope (%)	N/A
N/A	Painted X Walk1?	No	N/A	Painted X Walk2?	N/A
	X Walk 1 Direction	To W		X Walk 2 Direction	N/A
N/A	X Walk 1 Width (in)	N/A	N/A	X Walk 2 Width (in)	N/A
	X Walk 1 Slope (%)	2.2		X Walk 2 Slope (%)	N/A
	X Walk 1 X Slope (%)	0.9		X Walk 2 X Slope (%)	N/A

**Remove & Replace Entire Ramp.**

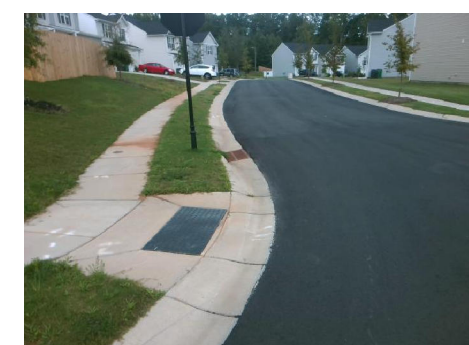
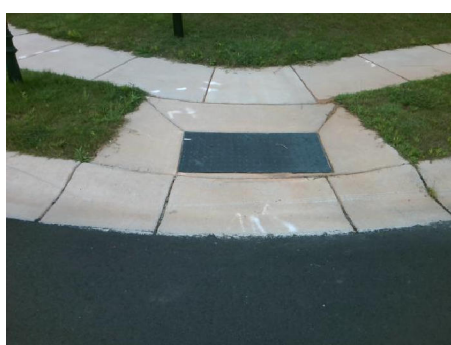
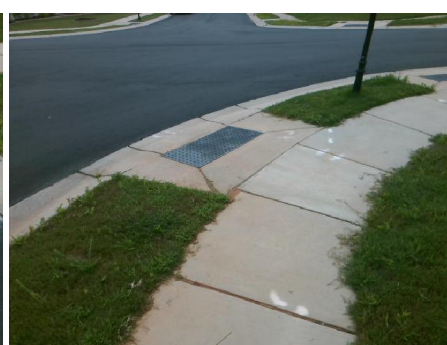
N/A	Ramp inside XWalk1?	N/A	N/A	Ramp inside XWalk2?	N/A
	Road Slope (%)	N/A	N/A	Clear Space?	N/A
	Road X Slope (%)	N/A	N/A	Clear Space to XWalk (in)	N/A
N/A	Any Obstructions?	N/A	N/A	Storm Grate/Utility Hazard?	N/A
	Obstruction Type			Storm Grate/Utility Type	
		N/A			N/A
			Yes	Surface Condition? (G/P)	Good
