Access Compliance Report Public Rights-of-Way (Curb Ramps)

Intersection ID: 44913Main Street:SPRINGHAVEN_DRCross Street:OAK_DRLocation:NWADA ID: B97505F7FB8BRamp Type:PerpDiagInitial Pass/Fail:FailOverall Compliance:NoSeverity Score:21.25

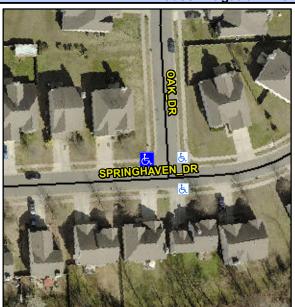
Field Measure	ments/C	ompo	nent Compliance	
Compliance Description			Comp	liance Description	Data
N/A	Ramp Length (in)	45.0	No	Ramp Slope (%)	9.9
No	Ramp Width (in)	36.0	Yes	Ramp XSlope (%)	0.7
N/A	Flare Type LT	N/A	N/A	Flare Type RT	N/A
N/A	Flare Slope LT (%)	N/A	N/A	Flare Slope RT (%)	N/A
N/A	Flare Traversable LT?	N/A	N/A	Flare Traversable RT?	N/A
N/A	Landing Length (in)	N/A	N/A	DWS Provided?	N/A
N/A	Landing Width (in)	N/A	N/A	DWS Contrast?	N/A
N/A	Landing Slope (%)	N/A	N/A	DWS Length (in)	N/A
N/A	Landing X Slope (%)	N/A	N/A	DWS Full Width?	N/A
N/A	Landing Curb? (Y/N)	N/A	N/A	DWS Offset (in)	N/A
N/A	Shared Landing?	N/A			
N/A	Gutter Ponding?	N/A	N/A	Gutter Slope (%)	N/A
N/A	Gutter Lip Ht (in)	N/A	N/A	Gutter X Slope (%)	N/A
N/A	Painted X Walk1?	No	N/A	Painted X Walk2?	No
	X Walk 1 Direction	To S		X Walk 2 Direction	To E
N/A	X Walk 1 Width (in)	N/A	N/A	X Walk 2 Width (in)	N/A
	X Walk 1 Slope (%)	0.7		X Walk 2 Slope (%)	2.5

X Walk 1 X Slope (%)	2.6		X Walk 2 X Slope (%)	2.3
N/A	Ramp inside XWalk1?	N/A	N/A	Ramp inside XWalk2?	N/A
	Road Slope (%)	0.9	N/A	Clear Space?	N/A
	Road X Slope (%)	0.5	N/A	Clear Space to XWalk (in)	N/A
N/A	Any Obstructions?	N/A	N/A	Storm Grate/Utility Hazard?	N/A
	Obstruction Type			Storm Grate/Utility Type	
		N/A			N/A
			Yes	Surface Condition? (G/P)	Good

Possible Solutions:				
Remove & Replace Curb Ramp With				
Two New Directional Ramps or	I			
Equivalent.	ı			
	ı			
	ı			
	ı			
Surveyor Notes:	I			
N/A	I			
	I			
	ı			
	ı			
PROW/ADA:	I			
Not Found, R304.5.1, R304.2.2	I			
	I

Total Cost:	\$ 3200.00
