Access Compliance Report

Public Rights-of-Way

(Curb Ramps)

Intersection ID: 17117	Main Street: CROYDON_RD	Cross Street: ROSWELL_AV	Location: SW
ADA ID: B977AE32D611	Ramp Type: Directional1	Initial Pass/Fail: Fail	Overall Compliance: No
Codes/Mitigation Info/Possible Solution		Field Measurements/Component Compliance	
Severity Score: 1.25

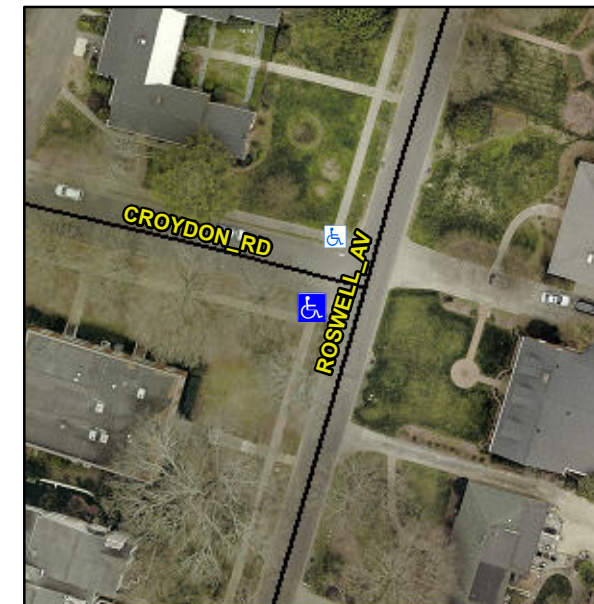
R304.5.3

Compliance	Description	Data	Compliance	Description	Data
N/A	Ramp Length (in)	86.0	N/A	Grade Break?	N/A
Yes	Ramp Width (in)	48.0	N/A	Grade Break Slope (%)	0.0
Yes	Ramp Slope (%)	8.0	N/A	Grade Break XSlope (%)	0.0
No	Ramp XSlope (%)	3.2			
N/A	Flare Type LT	N/A	N/A	Flare Type RT	N/A
N/A	Flare Slope LT (%)	N/A	N/A	Flare Slope RT (%)	0.0
N/A	Flare Traversable LT?	N/A	N/A	Flare Traversable RT?	N/A
N/A	Landing Length (in)	0.0	N/A	DWS Provided?	N/A
N/A	Landing Width (in)	0.0	N/A	DWS Contrast?	N/A
N/A	Landing Slope (%)	0.0	N/A	DWS Length (in)	N/A
N/A	Landing X Slope (%)	0.0	N/A	DWS Full Width?	N/A
N/A	Landing Curb? (Y/N)	N/A	N/A	DWS Offset LT (in)	N/A
N/A	Shared Landing?	N/A	N/A	DWS Offset RT (in)	N/A
N/A	Gutter Ponding?	Yes	N/A	Gutter Slope (%)	N/A
N/A	Gutter Lip Ht (in)	0.0	N/A	Gutter X Slope (%)	N/A
N/A	Painted X Walk1?	No		Road Slope (%)	0.1
	X Walk 1 Direction	To N		Road X Slope (%)	1.8
	X Walk 1 Width (in)	N/A		Clear Space?	N/A

X Walk 1 Slope (%)	0.1	N/A	Clear Space to XWalk (in)	N/A
	X Walk 1 X Slope (%)	1.8	N/A	Storm Grate/Utility Hazard?	N/A
N/A	Ramp inside XWalk1?	N/A		Storm Grate/Utility Type	
N/A	Any Obstructions?	N/A			N/A
	Obstruction Type		Yes	Surface Condition? (G/P)	Good
			N/A	Curb Slope (%)	6.7

Remove & Replace Entire Ramp.
