Access Compliance Report

Public Rights-of-Way

(Curb Ramps)

Intersection ID: 53624	Main Street: PROSPERITY RIDGE RD	Cross Street: RIDGE RD	Location: NE
ADA ID: B97C6E7D1A36	Ramp Type: Perp	Initial Pass/Fail: Fail	Overall Compliance: No
Severity Score: 13.75			
Codes/Mitigation Info/Possible Solution		Field Measurements/Component Compliance

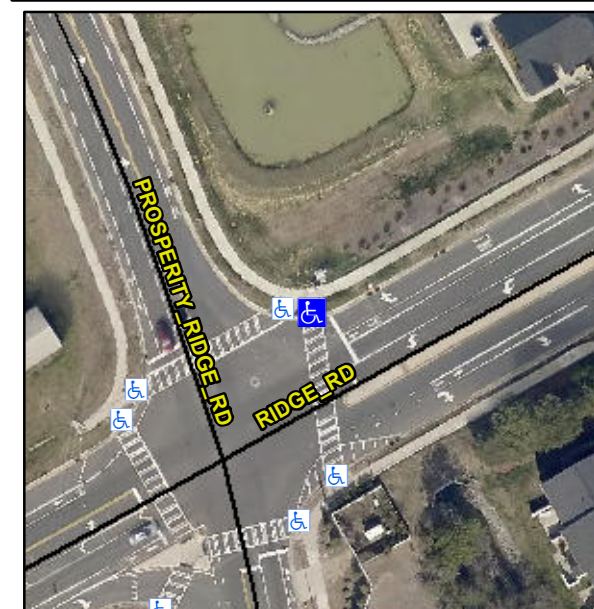
PROW/ADA:

R304.2.2, R304.5.3

Compliance	Description	Data	Compliance	Description	Data
N/A	Ramp Length (in)	105.0	No	Ramp Slope (%)	8.9
Yes	Ramp Width (in)	67.0	No	Ramp XSlope (%)	4.9
N/A	Flare Type LT	N/A	N/A	Flare Type RT	N/A
N/A	Flare Slope LT (%)	N/A	N/A	Flare Slope RT (%)	N/A
N/A	Flare Traversable LT?	N/A	N/A	Flare Traversable RT?	N/A
N/A	Landing Length (in)	N/A	N/A	DWS Provided?	N/A
N/A	Landing Width (in)	N/A	N/A	DWS Contrast?	N/A
N/A	Landing Slope (%)	N/A	N/A	DWS Length (in)	N/A
N/A	Landing X Slope (%)	N/A	N/A	DWS Full Width?	N/A
N/A	Landing Curb? (Y/N)	N/A	N/A	DWS Offset (in)	N/A
N/A	Shared Landing?	N/A			
N/A	Gutter Ponding?	N/A	N/A	Gutter Slope (%)	N/A
N/A	Gutter Lip Ht (in)	N/A	N/A	Gutter X Slope (%)	N/A
N/A	Painted X Walk1?	Yes	N/A	Painted X Walk2?	N/A
	X Walk 1 Direction	To S		X Walk 2 Direction	N/A
N/A	X Walk 1 Width (in)	111.5	N/A	X Walk 2 Width (in)	N/A
	X Walk 1 Slope (%)	1.1		X Walk 2 Slope (%)	N/A
	X Walk 1 X Slope (%)	3.3		X Walk 2 X Slope (%)	N/A

N/A	Ramp inside XWalk1?	Yes	N/A	Ramp inside XWalk2?	N/A
	Road Slope (%)	N/A	N/A	Clear Space?	N/A
	Road X Slope (%)	N/A	N/A	Clear Space to XWalk (in)	N/A
N/A	Any Obstructions?	N/A	N/A	Storm Grate/Utility Hazard?	N/A
	Obstruction Type			Storm Grate/Utility Type	
		N/A			N/A
		Yes		Surface Condition? (G/P)	Good

Possible Solutions:

Remove & Replace Entire Ramp.
