# Access Compliance Report

## Public Rights-of-Way

### (Curb Ramps)

Intersection ID: 53744	Main Street: SMITH_RD	Cross Street: CANTERBURY_CASTLE_DR	Location: NW
ADA ID: B9A04571099B	Ramp Type: BlendTrans1	Initial Pass/Fail: Fail	Overall Compliance: No
			Severity Score: 33.75

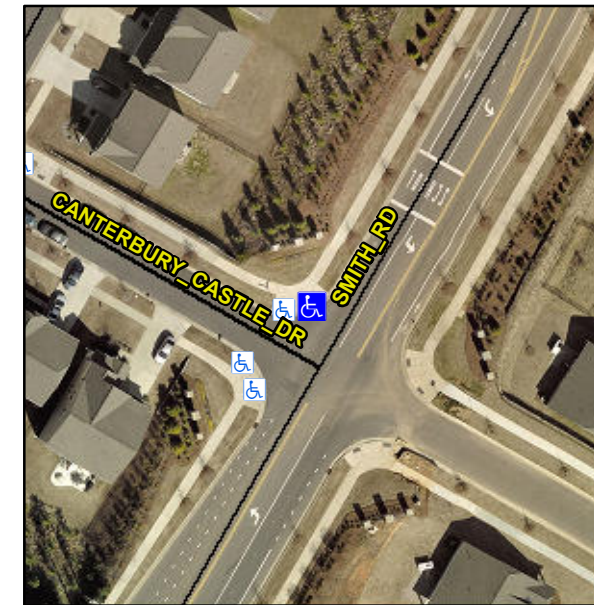
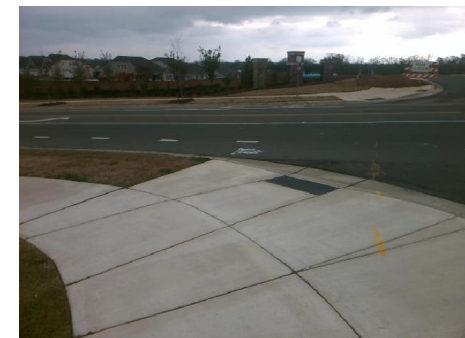
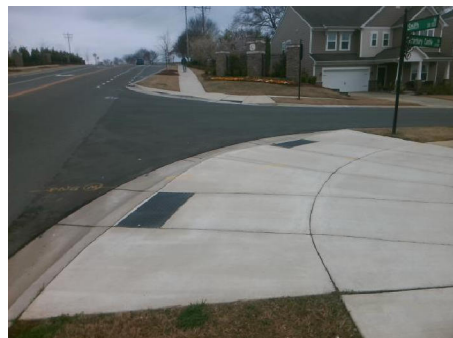
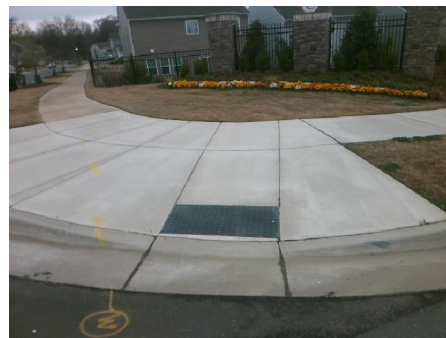
**Not Found, R304.5.1, R304.5.3**

Compliance	Description	Data	Compliance	Description	Data
N/A	Ramp Length (in)	96.0	Yes	BlendTrans Slope (%)	4.2
No	Ramp Width (in)	47.0	No	BlendTrans XSlope (%)	8.1
N/A	Flare Type LT	N/A	N/A	Flare Type RT	N/A
N/A	Flare Slope LT (%)	N/A	N/A	Flare Slope RT (%)	N/A
N/A	Flare Traversable LT?	N/A	N/A	Flare Traversable RT?	N/A
N/A	Landing Length (in)	N/A	N/A	DWS Provided?	N/A
N/A	Landing Width (in)	N/A	N/A	DWS Contrast?	N/A
N/A	Landing Slope (%)	N/A	N/A	DWS Length (in)	N/A
N/A	Landing X Slope (%)	N/A	N/A	DWS Full Width?	N/A
N/A	Landing Curb? (Y/N)	N/A	N/A	DWS Offset (in)	N/A
N/A	Shared Landing?	N/A			
N/A	Gutter Ponding?	N/A	N/A	Gutter Slope (%)	N/A
N/A	Gutter Lip Ht (in)	N/A	N/A	Gutter X Slope (%)	N/A
N/A	Painted X Walk1?	No	N/A	Painted X Walk2?	N/A
	X Walk 1 Direction	To SE		X Walk 2 Direction	N/A
	X Walk 1 Width (in)	N/A		X Walk 2 Width (in)	N/A
	X Walk 1 Slope (%)	5.2		X Walk 2 Slope (%)	N/A
	X Walk 1 X Slope (%)	7.1		X Walk 2 X Slope (%)	N/A

N/A	Ramp inside XWalk1?	N/A	N/A	Ramp inside XWalk2?	N/A
	Road Slope (%)	7.1		Clear Space?	N/A
	Road X Slope (%)	5.2	N/A	Clear Space to XWalk (in)	N/A
N/A	Any Obstructions?	N/A	N/A	Storm Grate/Utility Hazard?	N/A
	Obstruction Type			Storm Grate/Utility Type	
		N/A			N/A
			Yes	Surface Condition? (G/P)	Good
			No	Curb Slope (%)	6.2

**Remove & Replace Curb Ramp With Two New Directional Ramps or Equivalent.**
