Access Compliance Report Public Rights-of-Way (Curb Ramps)

Intersection ID: 47930 Main Street: MOORES_CHAPEL_RD **Cross Street: STRAUSE_DR** Location: ADA ID: B9B4D6E56AC5 Ramp Type: Perp Initial Pass/Fail: Pass **Overall Compliance: No Severity Score:** 2.5

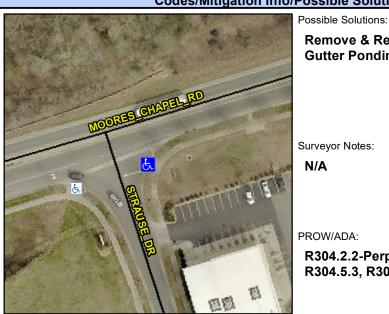
_
Remove & Replace Entire Ramp.	N
Gutter Ponding Observed.	Υ
	N
	N
	N
	Υ
Surveyor Notes:	Υ
N/A	N
	N
	N
	N
PROW/ADA:	N
R304.2.2-Perp, R304.3.2-Para,	Y
R304.5.3, R305.1.4, R305.2, R302.7	N
	N
	N

Field Measurements/Component Compliance								
Compl	iance Description	Data	Comp	liance	Description	Data		
N/A	Ramp Length (in)	96.0	Yes	Ramp	Slope (%)	6.5		
Yes	Ramp Width (in)	60.0	Yes	Ramp	XSlope (%)	0.8		
N/A	Flare Type LT	Sloped	N/A	Flare	Type RT	N/A		
N/A	Flare Slope LT (%)	6.4	Yes	Flare	Slope RT (%)	7.2		
N/A	Flare Traversable LT?	Yes	N/A	Flare	Traversable RT?	Yes		
Yes	Landing Length (in)	70.5	Yes	DWS	Provided?	Yes		
Yes	Landing Width (in)	60.0	Yes	DWS	Contrast?	Yes		
No	Landing Slope (%)	3.8	Yes	DWS	Length (in)	25.0		
No	Landing X Slope (%)	2.6	No	DWS	Full Width?	No		
N/A	Landing Curb? (Y/N)	No	No	DWS	Offset (in)	2.5		
N/A	Shared Landing?	No						
No	Gutter Ponding?	Yes	Yes	Gutte	r Slope (%)	2.2		
Yes	Gutter Lip Ht (in)	0.0	Yes	Gutte	r X Slope (%)	0.4		
N/A	Painted X Walk1?	No	N/A	Paint	ed X Walk2?	N/A		
	X Walk 1 Direction	To W		X Wa	lk 2 Direction	N/A		
N/A	X Walk 1 Width (in)	N/A	N/A	X Wa	lk 2 Width (in)	N/A

X Walk 1 Slope (%)	0.3		X Wa	lk 2 Slope (%)	N/A		
	X Walk 1 X Slope (%)	1.7		X Wa	lk 2 X Slope (%)	N/A		
N/A	Ramp inside XWalk1?	N/A	N/A	Ramp	inside XWalk2?	N/A		
	Road Slope (%)	N/A	N/A	Clear	Space?	Yes		
	Road X Slope (%)	N/A	N/A	Clear	Space to XWalk (in)	N/A		
Yes	Any Obstructions?	No	Yes	Storm	n Grate/Utility Hazard?	No		
	Obstruction Type			Storm	n Grate/Utility Type			
		N/A				N/A
