# Access Compliance Report

## Public Rights-of-Way

### (Curb Ramps)

Intersection ID: 15740	Main Street: DORCHESTER_PL	Cross Street: WRISTON_PL	Location:	E
ADA ID: B9BBAA69B8C6	Ramp Type: PerpDiag	Initial Pass/Fail: Fail	Overall Compliance: No	Severity Score: 25
Codes/Mitigation Info/Possible Solution		Field Measurements/Component Compliance

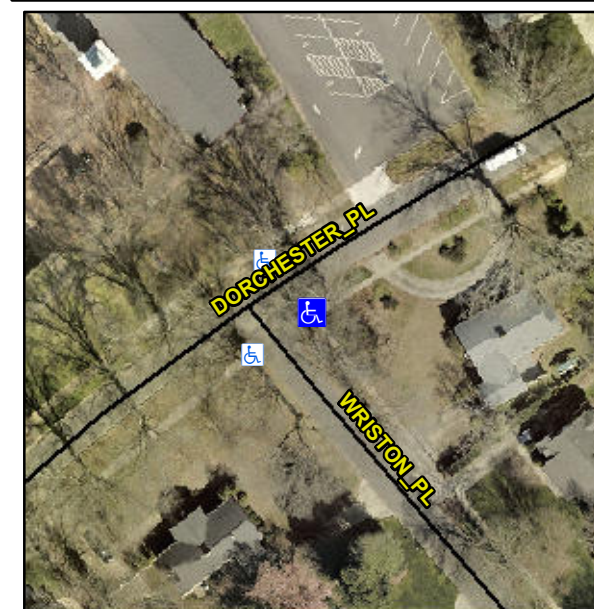
**Not Found, R304.2.2, R304.5.3**

Compliance	Description	Data	Compliance	Description	Data
N/A	Ramp Length (in)	40.0	No	Ramp Slope (%)	8.9
Yes	Ramp Width (in)	68.0	No	Ramp XSlope (%)	5.1
N/A	Flare Type LT	N/A	N/A	Flare Type RT	N/A
N/A	Flare Slope LT (%)	N/A	N/A	Flare Slope RT (%)	N/A
N/A	Flare Traversable LT?	N/A	N/A	Flare Traversable RT?	N/A
N/A	Landing Length (in)	N/A	N/A	DWS Provided?	N/A
N/A	Landing Width (in)	N/A	N/A	DWS Contrast?	N/A
N/A	Landing Slope (%)	N/A	N/A	DWS Length (in)	N/A
N/A	Landing X Slope (%)	N/A	N/A	DWS Full Width?	N/A
N/A	Landing Curb? (Y/N)	N/A	N/A	DWS Offset (in)	N/A
N/A	Shared Landing?	N/A			
N/A	Gutter Ponding?	N/A	N/A	Gutter Slope (%)	N/A
N/A	Gutter Lip Ht (in)	N/A	N/A	Gutter X Slope (%)	N/A
N/A	Painted X Walk1?	No	N/A	Painted X Walk2?	No
	X Walk 1 Direction	To NW		X Walk 2 Direction	To SW
N/A	X Walk 1 Width (in)	N/A	N/A	X Walk 2 Width (in)	N/A
	X Walk 1 Slope (%)	1.7		X Walk 2 Slope (%)	2.5
	X Walk 1 X Slope (%)	2.1		X Walk 2 X Slope (%)	2.1

N/A	Ramp inside XWalk1?	N/A	N/A	Ramp inside XWalk2?	N/A
	Road Slope (%)	1.9	N/A	Clear Space?	N/A
	Road X Slope (%)	1.1	N/A	Clear Space to XWalk (in)	N/A
N/A	Any Obstructions?	N/A	N/A	Storm Grate/Utility Hazard?	N/A
	Obstruction Type			Storm Grate/Utility Type	
		N/A			N/A
			Yes	Surface Condition? (G/P)	Good

**Remove & Replace Curb Ramp With Two New Directional Ramps or Equivalent.**

Total Cost: \$ 3200.00
