Access Compliance Report Public Rights-of-Way (Curb Ramps)

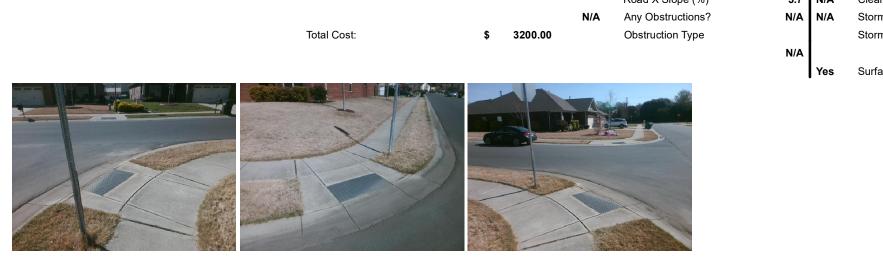
Intersection ID: 49697	ntersection ID: 49697 Main Street: HIGHLAND_MEADOW_RD				ross Street: MADISON_HILL_CT				NW
ADA ID: B9BE68EBCE	8EBCBBC Ramp Type: PerpDiag			Initial Pass/Fail: Fail Overall Compliance: No				o Severity Score:	37.5
Codes/Mitigation Info/Possible Solution				Field Measurements/Component Compliance					
		Possible Solutions:		Compliance Description			Data Compliance Description		Data
		Remove & Replace Curb Ra	n With	N/A	Ramp Length (in)	46.5	No	Ramp Slope (%)	8.8
		Two New Directional Ramps	•	Yes	Ramp Width (in)	48.0	No	Ramp XSlope (%)	15.0
		Equivalent.		N/A	Flare Type LT	N/A	N/A	Flare Type RT	N/A
				N/A	Flare Slope LT (%)	N/A	N/A	Flare Slope RT (%)	N/A
				N/A	Flare Traversable LT?	N/A	N/A	Flare Traversable RT?	N/A
				N/A	Landing Length (in)	N/A	N/A	DWS Provided?	N/A
The there		Surveyor Notes:		N/A	Landing Width (in)	N/A	N/A	DWS Contrast?	N/A
10-25-07		N/A		N/A	Landing Slope (%)	N/A	N/A	DWS Length (in)	N/A

N HILL GT			N/A	Landing X Slope (%)	N/A	N/A	DWS Full Width?	N/A
MADISS	<u>a</u> <u>a</u>			N/A	Landing Curb? (Y/N)	N/A	N/A	DWS Offset (in)	N/A
				N/A	Shared Landing?	N/A			
and the second		PROW/ADA:		N/A	Gutter Ponding?	N/A	N/A	Gutter Slope (%)	N/A
	NY UT	Not Found, R304.2.2, R304.5.3	3	N/A	Gutter Lip Ht (in)	N/A	N/A	Gutter X Slope (%)	N/A
TVAIL	1. 1	·····, ·····, ·····, ······, ·····	-	N/A	Painted X Walk1?	No	N/A	Painted X Walk2?	No
					X Walk 1 Direction	To S		X Walk 2 Direction	To E
			N/A	X Walk 1 Width (in)	N/A	N/A	X Walk 2 Width (in)	N/A	
Street 1 Name	MADISON HILL CT	_			X Walk 1 Slope (%)	1.4		X Walk 2 Slope (%)	1.1
Stop Condition-Street 2	None				X Walk 1 X Slope (%)	1.7		X Walk 2 X Slope (%)	0.9
Street 2 Name	HIGHLAND MEADOW RD			N/A	Ramp inside XWalk1?	N/A	N/A	Ramp inside XWalk2?	N/A
Stop Condition-Street 1	StopSign				Road Slope (%)	0.1	N/A	Clear Space?	N/A
					Road X Slope (%)	3.7	N/A	Clear Space to XWalk (in)	N/A

N/A	Any Obstructions?	N/A	N/A	Storm Grate/Utility Hazard?	N/A
		Total Cost: \$	3200.00		Obstruction Type			Storm Grate/Utility Type	
						N/A			N/A
