Access Compliance Report Public Rights-of-Way (Curb Ramps)

Intersection ID: 10867 Main Street: E_35TH_ST Cross Street: THE_PLAZA Location: S

ADA ID: B9DBF997B253 Ramp Type: PerpDiag Initial Pass/Fail: Fail Overall Compliance: No Severity Score: 12.5

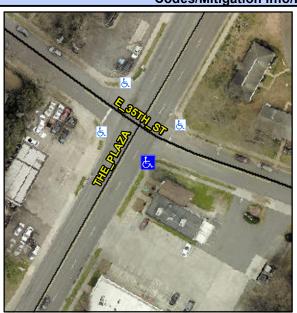
Ticia incusurements/somponent somphanee				
Compliance Description		Data	Compl	ance Description
N/A	Ramp Length (in)	50.0	No	Ramp Slope (%)
Yes	Ramp Width (in)	48.0	Yes	Ramp XSlope (%)
N/A	Flare Type LT	N/A	N/A	Flare Type RT
N/A	Flare Slope LT (%)	N/A	N/A	Flare Slope RT (%)
N/A	Flare Traversable LT?	N/A	N/A	Flare Traversable RT?
N/A	Landing Length (in)	N/A	N/A	DWS Provided?
N/A	Landing Width (in)	N/A	N/A	DWS Contrast?
N/A	Landing Slope (%)	N/A	N/A	DWS Length (in)
N/A	Landing X Slope (%)	N/A	N/A	DWS Full Width?
N/A	Landing Curb? (Y/N)	N/A	N/A	DWS Offset (in)
N/A	Shared Landing?	N/A		
N/A	Gutter Ponding?	N/A	N/A	Gutter Slope (%)
N/A	Gutter Lip Ht (in)	2.0	N/A	Gutter X Slope (%)
N/A	Painted X Walk1?	No	N/A	Painted X Walk2?
	X Walk 1 Direction	To NE		X Walk 2 Direction
N/A	X Walk 1 Width (in)	N/A	N/A	X Walk 2 Width (in)
	X Walk 1 Slope (%)	1.3		X Walk 2 Slope (%)
	X Walk 1 X Slope (%)	0.6		X Walk 2 X Slope (%)
N/A	Ramp inside XWalk1?	N/A	N/A	Ramp inside XWalk2?

Remove & Replace Curb Ramp With Two New Directional Ramps or Equivalent.

R304.2.2

Total Cost: \$ 3200.00
