Access Compliance Report

Public Rights-of-Way

(Curb Ramps)

| Intersection ID: 3797 | Main Street: HARRIS_CENTER_DR | Cross Street: HENDRY_RD | Location: SW |

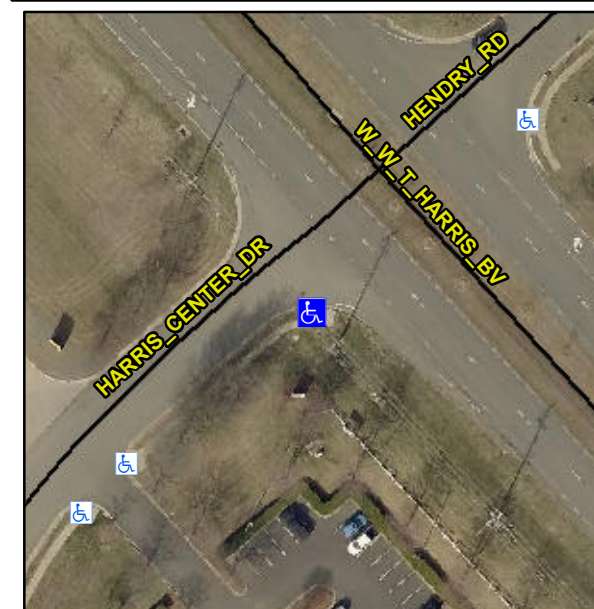
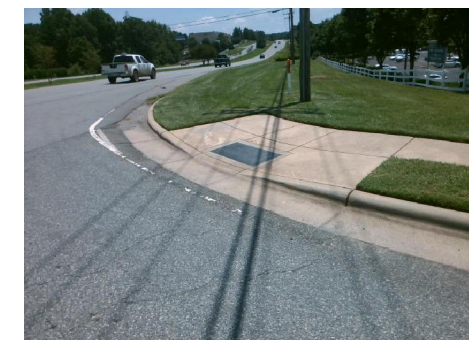
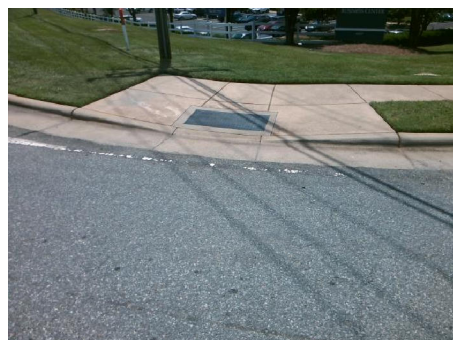
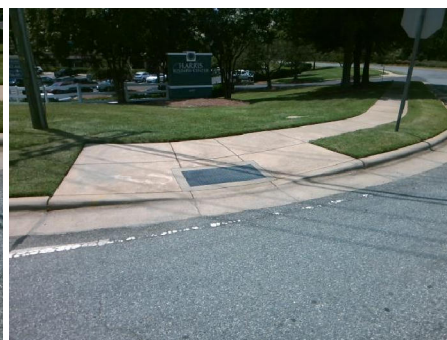
| ADA ID: B9E4F9293E61 | Ramp Type: Perp | Initial Pass/Fail: Fail | Overall Compliance: No |
| Severity Score: 8.75 | | | |

Not Found, R304.5.1

| Compliance | Description | Data | Compliance | Description | Data |
|---|---|---|---|---|---|
| No | Ramp Width (in) | 42.0 | Yes | Ramp XSlope (%) | 0.9 |

Remove & Replace Entire Ramp.

Total Cost: \$ 1850.00
