# Access Compliance Report

## Public Rights-of-Way

| Intersection ID: 13487 | Main Street: S_MINT_ST | Cross Street: W_KINGSTON_AV | Location: W |
| ADA ID: B9EA07889982 | Ramp Type: BlendTrans2 | Initial Pass/Fail: Fail | Overall Compliance: No |

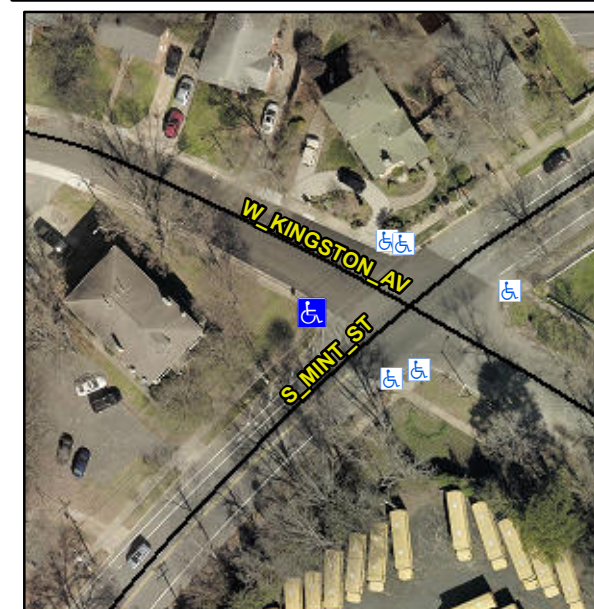
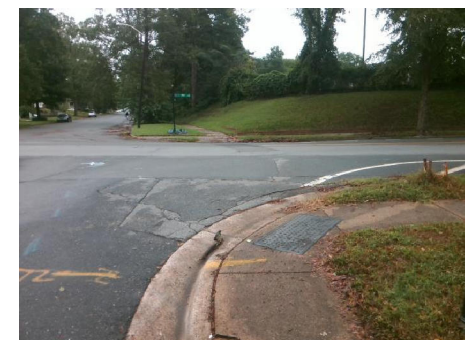
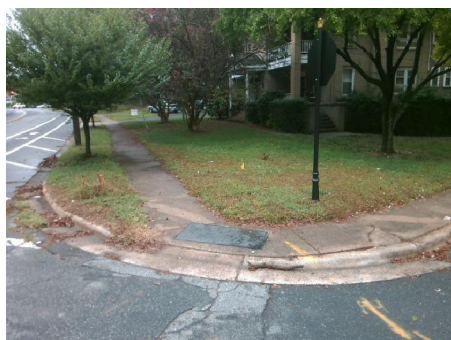
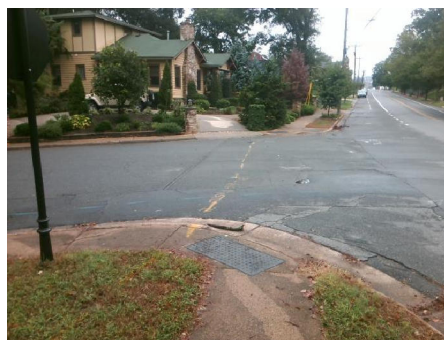
| Severity Score: 12.5 | | | |

**Not Found, R304.5.3**

| Compliance | Description | Data | Compliance | Description | Data |
|---|---|---|---|---|---|
| Yes | Ramp Width (in) | 48.0 | No | BlendTrans XSlope (%) | 6.5 |
| | | | No | Curb Slope (%) | 17.2 |

**Remove & Replace Curb Ramp With Two New Directional Ramps or Equivalent.**

Total Cost: \$ 3200.00
