# Access Compliance Report

## Public Rights-of-Way

### (Curb Ramps)

| Intersection ID: 42798 | Main Street: CRIMSON_SARGENT_DR | Cross Street: LADY_CLARE_DR | Location: SW |

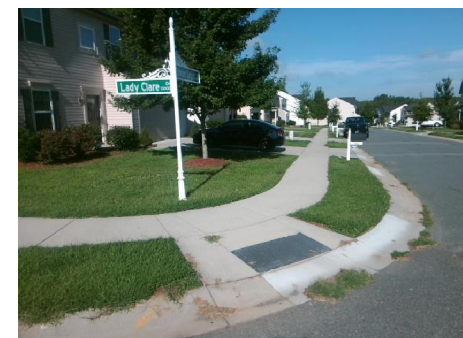
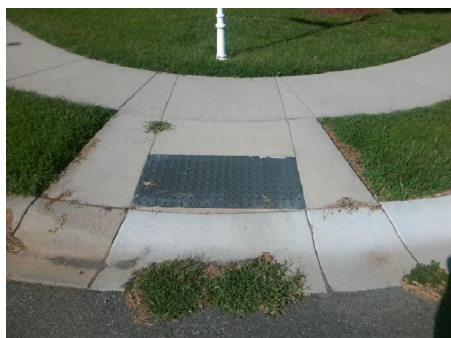
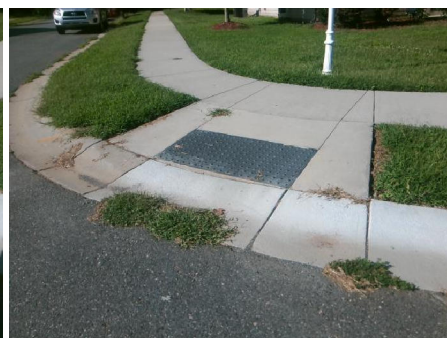
| ADA ID: BA0C05553EC8 | Ramp Type: PerpDiag | Initial Pass/Fail: Fail | Overall Compliance: No |

**Not Found, R304.5.1, R304.2.2**

| Compliance | Description | Data | Compliance | Description | Data |
|---|---|---|---|---|---|
| N/A | Ramp Length (in) | 48.5 | No | Ramp Slope (%) | 11.3 |
| No | Ramp Width (in) | 47.0 | Yes | Ramp XSlope (%) | 1.5 |

**Remove & Replace Curb Ramp With Two New Directional Ramps or Equivalent.**
