Access Compliance Report

Public Rights-of-Way

(Curb Ramps)

Intersection ID: 10844	Main Street: W_5TH_ST	Cross Street: FRAZIER_AV	Location: W
ADA ID: BA0C59FE625F	Ramp Type: PerpDiag	Initial Pass/Fail: Fail	Overall Compliance: No
		Severity Score: 42.5

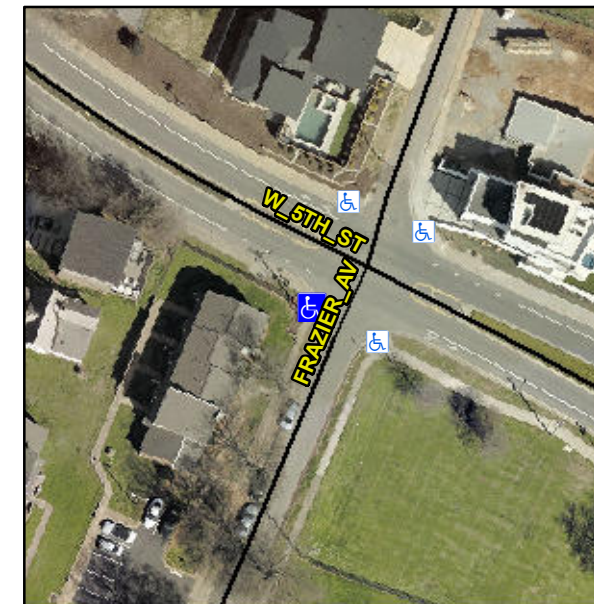
Not Found, R304.5.1, R304.2.2, R304.5.3

Compliance	Description	Data	Compliance	Description	Data
N/A	Ramp Length (in)	58.5	No	Ramp Slope (%)	9.0
No	Ramp Width (in)	33.5	No	Ramp XSlope (%)	6.6
N/A	Flare Type LT	N/A	N/A	Flare Type RT	N/A
N/A	Flare Slope LT (%)	N/A	N/A	Flare Slope RT (%)	N/A
N/A	Flare Traversable LT?	N/A	N/A	Flare Traversable RT?	N/A
N/A	Landing Length (in)	N/A	N/A	DWS Provided?	N/A
N/A	Landing Width (in)	N/A	N/A	DWS Contrast?	N/A
N/A	Landing Slope (%)	N/A	N/A	DWS Length (in)	N/A
N/A	Landing X Slope (%)	N/A	N/A	DWS Full Width?	N/A
N/A	Landing Curb? (Y/N)	N/A	N/A	DWS Offset (in)	N/A
N/A	Shared Landing?	N/A			
N/A	Gutter Ponding?	N/A	N/A	Gutter Slope (%)	N/A
N/A	Gutter Lip Ht (in)	N/A	N/A	Gutter X Slope (%)	N/A
N/A	Painted X Walk1?	No	N/A	Painted X Walk2?	No
	X Walk 1 Direction	To SE		X Walk 2 Direction	To NE
N/A	X Walk 1 Width (in)	N/A	N/A	X Walk 2 Width (in)	N/A
	X Walk 1 Slope (%)	4.1		X Walk 2 Slope (%)	5.0
	X Walk 1 X Slope (%)	4.0		X Walk 2 X Slope (%)	5.0

N/A	Ramp inside XWalk1?	N/A	N/A	Ramp inside XWalk2?	N/A
	Road Slope (%)	4.9	N/A	Clear Space?	N/A
	Road X Slope (%)	3.2	N/A	Clear Space to XWalk (in)	N/A
N/A	Any Obstructions?	N/A	N/A	Storm Grate/Utility Hazard?	N/A
	Obstruction Type			Storm Grate/Utility Type	
		N/A			N/A
			Yes	Surface Condition? (G/P)	Good

Remove & Replace Curb Ramp With Two New Directional Ramps or Equivalent.
