Access Compliance Report

Public Rights-of-Way

(Curb Ramps)

Intersection ID: 47837	Main Street: CACTUS_VALLEY_RD	Cross Street: DRAGONFLY_LN	Location: NE
ADA ID: BA2150B47E46	Ramp Type: PerpDiag	Initial Pass/Fail: Fail	Overall Compliance: No
Severity Score: 10			
Codes/Mitigation Info/Possible Solution		Field Measurements/Component Compliance

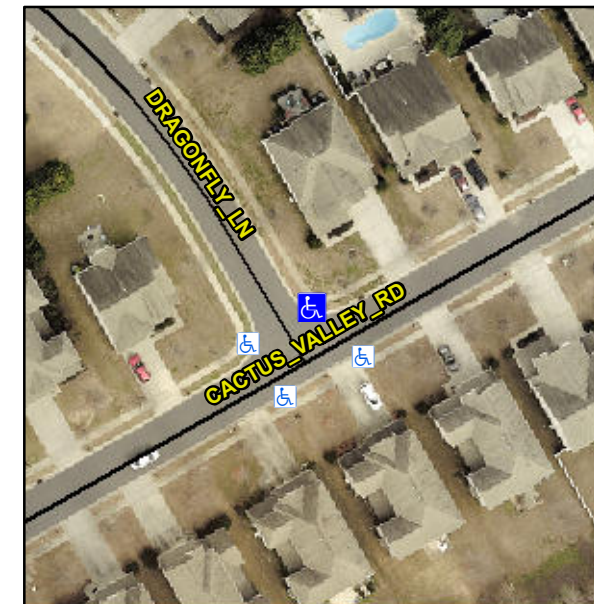
Not Found, R304.5.1, R304.5.3

Compliance	Description	Data	Compliance	Description	Data
N/A	Ramp Length (in)	47.0	Yes	Ramp Slope (%)	7.8
No	Ramp Width (in)	47.0	No	Ramp XSlope (%)	4.2
N/A	Flare Type LT	N/A	N/A	Flare Type RT	N/A
N/A	Flare Slope LT (%)	N/A	N/A	Flare Slope RT (%)	N/A
N/A	Flare Traversable LT?	N/A	N/A	Flare Traversable RT?	N/A
N/A	Landing Length (in)	N/A	N/A	DWS Provided?	N/A
N/A	Landing Width (in)	N/A	N/A	DWS Contrast?	N/A
N/A	Landing Slope (%)	N/A	N/A	DWS Length (in)	N/A
N/A	Landing X Slope (%)	N/A	N/A	DWS Full Width?	N/A
N/A	Landing Curb? (Y/N)	N/A	N/A	DWS Offset (in)	N/A
N/A	Shared Landing?	N/A			
N/A	Gutter Ponding?	N/A	N/A	Gutter Slope (%)	N/A
N/A	Gutter Lip Ht (in)	N/A	N/A	Gutter X Slope (%)	N/A
N/A	Painted X Walk1?	No	N/A	Painted X Walk2?	No
	X Walk 1 Direction	To SW		X Walk 2 Direction	To SE
N/A	X Walk 1 Width (in)	N/A	N/A	X Walk 2 Width (in)	N/A
	X Walk 1 Slope (%)	3.4		X Walk 2 Slope (%)	0.2
	X Walk 1 X Slope (%)	0.6		X Walk 2 X Slope (%)	0.7

N/A	Ramp inside XWalk1?	N/A	N/A	Ramp inside XWalk2?	N/A
	Road Slope (%)	0.5	N/A	Clear Space?	N/A
	Road X Slope (%)	0.7	N/A	Clear Space to XWalk (in)	N/A
N/A	Any Obstructions?	N/A	N/A	Storm Grate/Utility Hazard?	N/A
	Obstruction Type			Storm Grate/Utility Type	
		N/A			N/A
			Yes	Surface Condition? (G/P)	Good

Remove & Replace Curb Ramp With Two New Directional Ramps or Equivalent.
