# Access Compliance Report

## Public Rights-of-Way

### (Curb Ramps)

Intersection ID: 42729	Main Street: CALDWELL_FOREST_DR	Cross Street: COCHRAN_RIDGE_AV	Location: SW
ADA ID: BA28DDAFF3AE	Ramp Type: PerpDiag	Initial Pass/Fail: Fail	Overall Compliance: No
Severity Score: 10			
Codes/Mitigation Info/Possible Solution		Field Measurements/Component Compliance

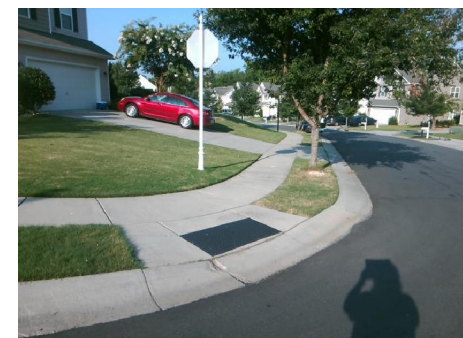
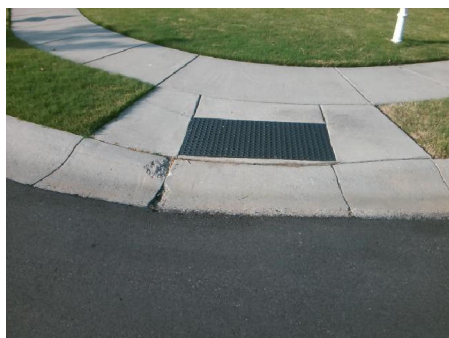
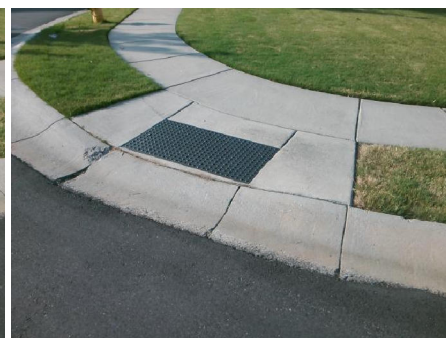
**Not Found, R304.5.1, R304.5.3**

Compliance	Description	Data	Compliance	Description	Data
N/A	Ramp Length (in)	43.5	Yes	Ramp Slope (%)	6.8
No	Ramp Width (in)	47.5	No	Ramp XSlope (%)	4.5
N/A	Flare Type LT	N/A	N/A	Flare Type RT	N/A
N/A	Flare Slope LT (%)	N/A	N/A	Flare Slope RT (%)	N/A
N/A	Flare Traversable LT?	N/A	N/A	Flare Traversable RT?	N/A
N/A	Landing Length (in)	N/A	N/A	DWS Provided?	N/A
N/A	Landing Width (in)	N/A	N/A	DWS Contrast?	N/A
N/A	Landing Slope (%)	N/A	N/A	DWS Length (in)	N/A
N/A	Landing X Slope (%)	N/A	N/A	DWS Full Width?	N/A
N/A	Landing Curb? (Y/N)	N/A	N/A	DWS Offset (in)	N/A
N/A	Shared Landing?	N/A			
N/A	Gutter Ponding?	N/A	N/A	Gutter Slope (%)	N/A
N/A	Gutter Lip Ht (in)	N/A	N/A	Gutter X Slope (%)	N/A
N/A	Painted X Walk1?	No	N/A	Painted X Walk2?	No
	X Walk 1 Direction	To SE		X Walk 2 Direction	To NW
N/A	X Walk 1 Width (in)	N/A	N/A	X Walk 2 Width (in)	N/A
	X Walk 1 Slope (%)	8.6		X Walk 2 Slope (%)	3.8
	X Walk 1 X Slope (%)	2.4		X Walk 2 X Slope (%)	7.3

N/A	Ramp inside XWalk1?	N/A	N/A	Ramp inside XWalk2?	N/A
	Road Slope (%)	4.7	N/A	Clear Space?	N/A
	Road X Slope (%)	6.1	N/A	Clear Space to XWalk (in)	N/A
N/A	Any Obstructions?	N/A	N/A	Storm Grate/Utility Hazard?	N/A
	Obstruction Type			Storm Grate/Utility Type	
		N/A			N/A
		Yes		Surface Condition? (G/P)	Good

**Remove & Replace Curb Ramp With Two New Directional Ramps or Equivalent.**
