Access Compliance Report

Public Rights-of-Way

(Curb Ramps)

Intersection ID: 17696	Main Street: DENON_HILLS_DR	Cross Street: E W T HARRIS BV	Location: SW
ADA ID: BA30C66A89B9	Ramp Type: PerpDiag	Initial Pass/Fail: Fail	Overall Compliance: No
Severity Score: 21.25			
Codes/Mitigation Info/Possible Solution		Field Measurements/Component Compliance

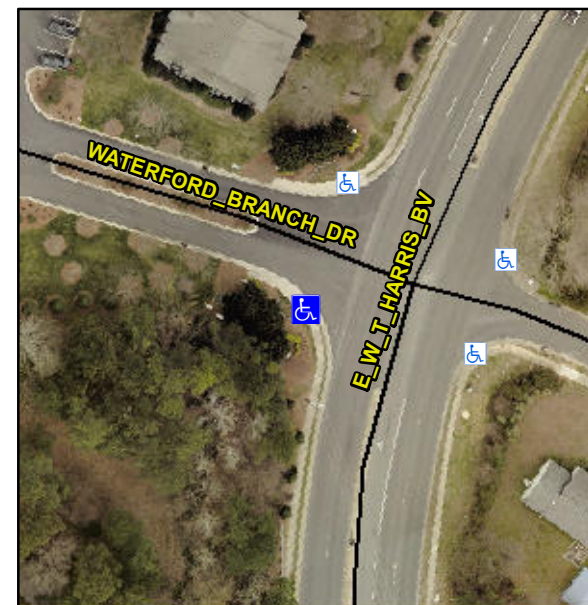
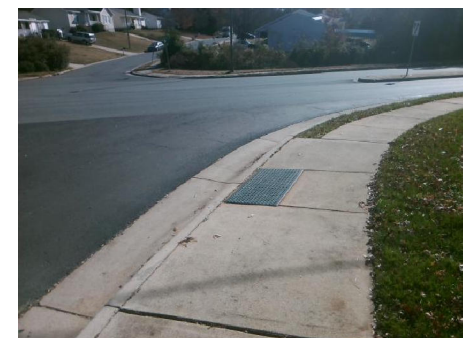
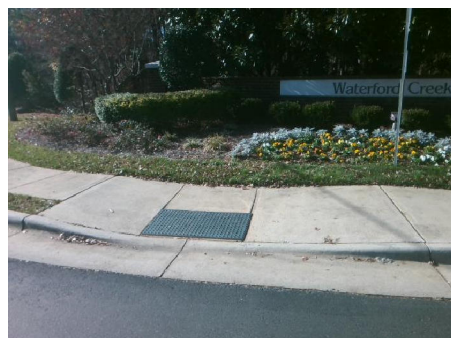
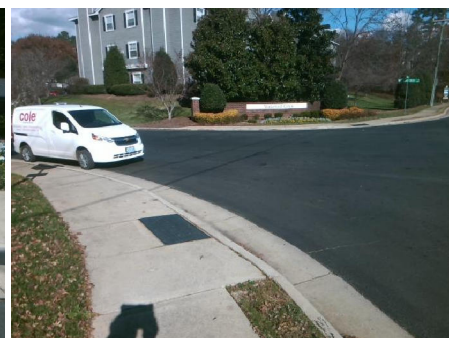
Not Found, R304.5.1, R304.2.2

Compliance	Description	Data	Compliance	Description	Data
N/A	Ramp Length (in)	27.5	No	Ramp Slope (%)	8.4
No	Ramp Width (in)	46.5	Yes	Ramp XSlope (%)	0.2
N/A	Flare Type LT	N/A	N/A	Flare Type RT	N/A
N/A	Flare Slope LT (%)	N/A	N/A	Flare Slope RT (%)	N/A
N/A	Flare Traversable LT?	N/A	N/A	Flare Traversable RT?	N/A
N/A	Landing Length (in)	N/A	N/A	DWS Provided?	N/A
N/A	Landing Width (in)	N/A	N/A	DWS Contrast?	N/A
N/A	Landing Slope (%)	N/A	N/A	DWS Length (in)	N/A
N/A	Landing X Slope (%)	N/A	N/A	DWS Full Width?	N/A
N/A	Landing Curb? (Y/N)	N/A	N/A	DWS Offset (in)	N/A
N/A	Shared Landing?	N/A			
N/A	Gutter Ponding?	N/A	N/A	Gutter Slope (%)	N/A
N/A	Gutter Lip Ht (in)	N/A	N/A	Gutter X Slope (%)	N/A
N/A	Painted X Walk1?	No	N/A	Painted X Walk2?	No
	X Walk 1 Direction	To SE		X Walk 2 Direction	To NE
N/A	X Walk 1 Width (in)	N/A	N/A	X Walk 2 Width (in)	N/A
	X Walk 1 Slope (%)	0.4		X Walk 2 Slope (%)	2.1
	X Walk 1 X Slope (%)	1.0		X Walk 2 X Slope (%)	1.1

N/A	Ramp inside XWalk1?	N/A	N/A	Ramp inside XWalk2?	N/A
	Road Slope (%)	1.3	N/A	Clear Space?	N/A
	Road X Slope (%)	3.0	N/A	Clear Space to XWalk (in)	N/A
N/A	Any Obstructions?	N/A	N/A	Storm Grate/Utility Hazard?	N/A
	Obstruction Type			Storm Grate/Utility Type	
		N/A			N/A
			Yes	Surface Condition? (G/P)	Good

Possible Solutions:

Remove & Replace Curb Ramp With Two New Directional Ramps or Equivalent.
