# Access Compliance Report

## Public Rights-of-Way

### (Curb Ramps)

| Intersection ID: 2853 | Main Street: CARDINAL_POINT_RD | Cross Street: BENFIELD_RD | Location: SW |

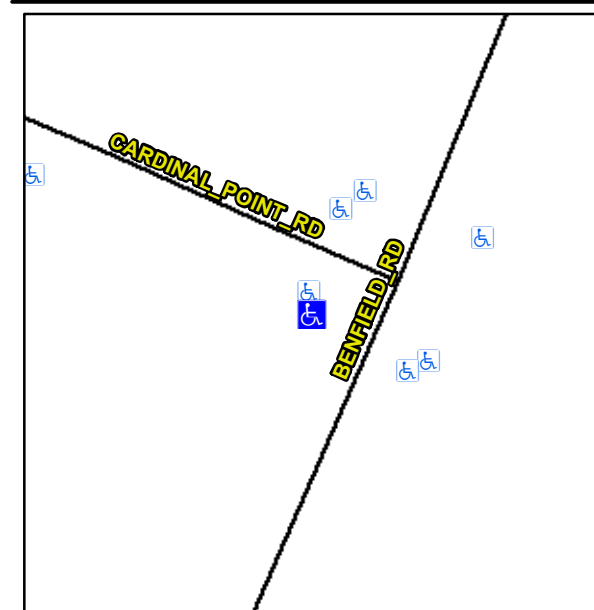
| ADA ID: BA32FD55DFAF | Ramp Type: Directional1 | Initial Pass/Fail: Pass | Overall Compliance: No |
| Severity Score: 5.25 | | | |

**R304.5.3, R304.2.3**

| Compliance | Description | Data | Compliance | Description | Data |
|---|---|---|---|---|---|
| No | Ramp XSlope (%) | 3.3 | | | |
| Yes | Gutter Lip Ht (in) | 0.0 | No | Gutter X Slope (%) | 3.6 |

Possible Solutions:

**Remove & Replace Entire Ramp.  
Remove & Replace Gutter.**
