# Access Compliance Report

## Public Rights-of-Way

### (Curb Ramps)

Intersection ID: N/A	Main Street: COSTIGAN_LN	Cross Street: N/A	Location: NE
ADA ID: BA36EDD33121	Ramp Type: PerpDiag	Initial Pass/Fail: Fail	Overall Compliance: No
Severity Score: 21.25			
Codes/Mitigation Info/Possible Solution		Field Measurements/Component Compliance

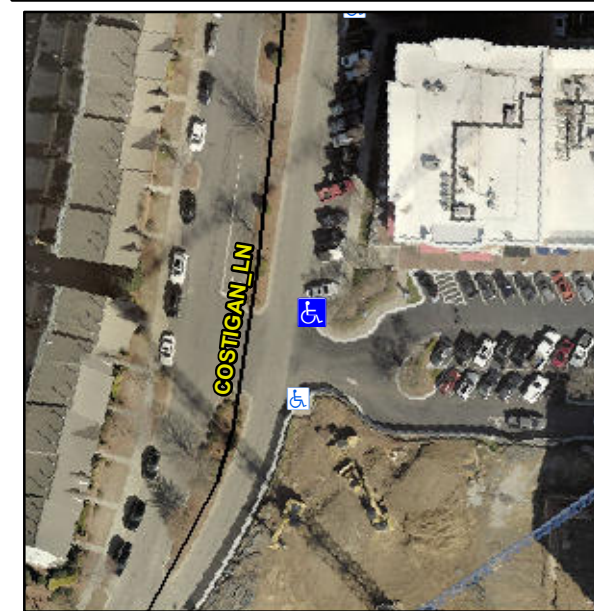
**Not Found, R304.5.1, R304.5.3**

Compliance	Description	Data	Compliance	Description	Data
N/A	Ramp Length (in)	59.0	Yes	Ramp Slope (%)	7.2
No	Ramp Width (in)	45.0	No	Ramp XSlope (%)	5.9
N/A	Flare Type LT	N/A	N/A	Flare Type RT	N/A
N/A	Flare Slope LT (%)	N/A	N/A	Flare Slope RT (%)	N/A
N/A	Flare Traversable LT?	N/A	N/A	Flare Traversable RT?	N/A
N/A	Landing Length (in)	N/A	N/A	DWS Provided?	N/A
N/A	Landing Width (in)	N/A	N/A	DWS Contrast?	N/A
N/A	Landing Slope (%)	N/A	N/A	DWS Length (in)	N/A
N/A	Landing X Slope (%)	N/A	N/A	DWS Full Width?	N/A
N/A	Landing Curb? (Y/N)	N/A	N/A	DWS Offset (in)	N/A
N/A	Shared Landing?	N/A			
N/A	Gutter Ponding?	N/A	N/A	Gutter Slope (%)	N/A
N/A	Gutter Lip Ht (in)	N/A	N/A	Gutter X Slope (%)	N/A
N/A	Painted X Walk1?	No	N/A	Painted X Walk2?	No
	X Walk 1 Direction	To W		X Walk 2 Direction	To S
N/A	X Walk 1 Width (in)	N/A	N/A	X Walk 2 Width (in)	N/A
	X Walk 1 Slope (%)	1.0		X Walk 2 Slope (%)	0.4
	X Walk 1 X Slope (%)	0.3		X Walk 2 X Slope (%)	5.7

N/A	Ramp inside XWalk1?	N/A	N/A	Ramp inside XWalk2?	N/A
	Road Slope (%)	3.8	N/A	Clear Space?	N/A
	Road X Slope (%)	4.0	N/A	Clear Space to XWalk (in)	N/A
N/A	Any Obstructions?	N/A	N/A	Storm Grate/Utility Hazard?	N/A
	Obstruction Type			Storm Grate/Utility Type	
		N/A			N/A
		Yes		Surface Condition? (G/P)	Good

**Remove & Replace Curb Ramp With Two New Directional Ramps or Equivalent.**

Total Cost: \$ 3200.00
