Access Compliance Report

Public Rights-of-Way

(Curb Ramps)

Intersection ID: 48451	Main Street: RED_RUST_LN	Cross Street: DANCING_WIND_RD	Location: NE
ADA ID: BA377583FAFF	Ramp Type: Perp	Initial Pass/Fail: Fail	Overall Compliance: No
Severity Score: 8.75			
Codes/Mitigation Info/Possible Solution		Field Measurements/Component Compliance

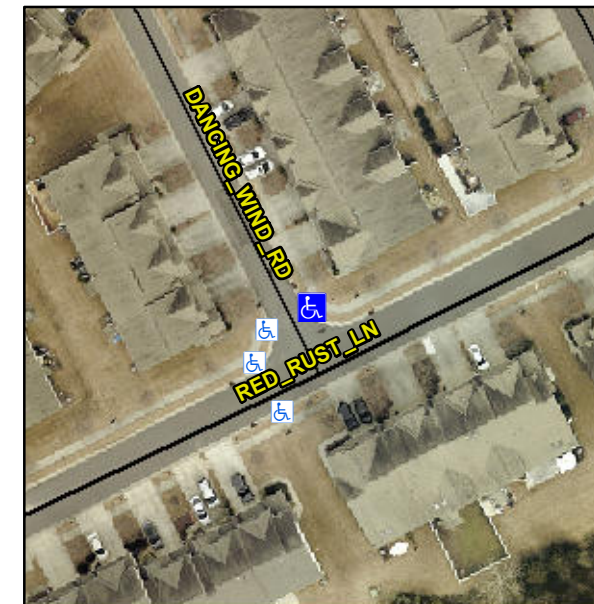
Not Found, R304.5.1

Compliance	Description	Data	Compliance	Description	Data
N/A	Ramp Length (in)	47.0	Yes	Ramp Slope (%)	5.3
No	Ramp Width (in)	47.0	Yes	Ramp XSlope (%)	1.1
N/A	Flare Type LT	N/A	N/A	Flare Type RT	N/A
N/A	Flare Slope LT (%)	N/A	N/A	Flare Slope RT (%)	N/A
N/A	Flare Traversable LT?	N/A	N/A	Flare Traversable RT?	N/A
N/A	Landing Length (in)	N/A	N/A	DWS Provided?	N/A
N/A	Landing Width (in)	N/A	N/A	DWS Contrast?	N/A
N/A	Landing Slope (%)	N/A	N/A	DWS Length (in)	N/A
N/A	Landing X Slope (%)	N/A	N/A	DWS Full Width?	N/A
N/A	Landing Curb? (Y/N)	N/A	N/A	DWS Offset (in)	N/A
N/A	Shared Landing?	N/A			
N/A	Gutter Ponding?	N/A	N/A	Gutter Slope (%)	N/A
N/A	Gutter Lip Ht (in)	N/A	N/A	Gutter X Slope (%)	N/A
N/A	Painted X Walk1?	No	N/A	Painted X Walk2?	N/A
	X Walk 1 Direction	To SW		X Walk 2 Direction	N/A
N/A	X Walk 1 Width (in)	N/A	N/A	X Walk 2 Width (in)	N/A
	X Walk 1 Slope (%)	0.3		X Walk 2 Slope (%)	N/A
	X Walk 1 X Slope (%)	0.2		X Walk 2 X Slope (%)	N/A

N/A	Ramp inside XWalk1?	N/A	N/A	Ramp inside XWalk2?	N/A
	Road Slope (%)	N/A	N/A	Clear Space?	N/A
	Road X Slope (%)	N/A	N/A	Clear Space to XWalk (in)	N/A
N/A	Any Obstructions?	N/A	N/A	Storm Grate/Utility Hazard?	N/A
	Obstruction Type			Storm Grate/Utility Type	
		N/A			N/A
			Yes	Surface Condition? (G/P)	Good

Remove & Replace Entire Ramp.
