Access Compliance Report

Public Rights-of-Way

(Curb Ramps)

Intersection ID: 30579	Main Street: CIRCLEGREEN_DR	Cross Street: TRICKLING_WATER_CT	Location: E
ADA ID: BA3CF5396245	Ramp Type: PerpDiag	Initial Pass/Fail: Fail	Overall Compliance: No
		Severity Score: 25

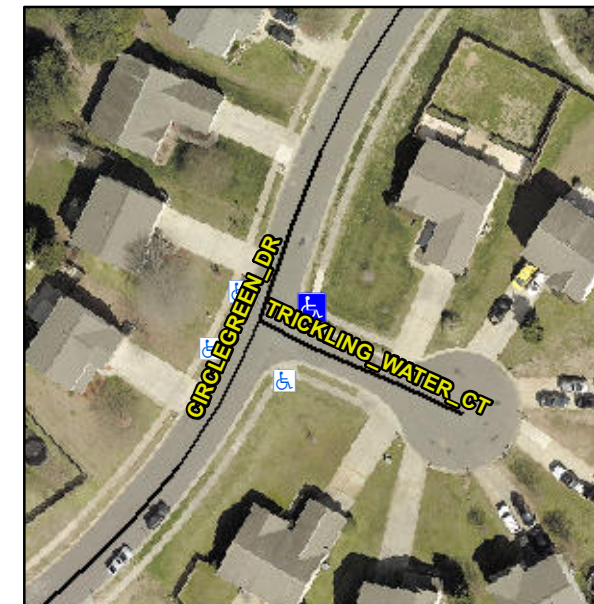
Not Found, R304.5.3

Compliance	Description	Data	Compliance	Description	Data
N/A	Ramp Length (in)	46.0	Yes	Ramp Slope (%)	6.9
Yes	Ramp Width (in)	48.0	No	Ramp XSlope (%)	9.9
N/A	Flare Type LT	N/A	N/A	Flare Type RT	N/A
N/A	Flare Slope LT (%)	N/A	N/A	Flare Slope RT (%)	N/A
N/A	Flare Traversable LT?	N/A	N/A	Flare Traversable RT?	N/A
N/A	Landing Length (in)	N/A	N/A	DWS Provided?	N/A
N/A	Landing Width (in)	N/A	N/A	DWS Contrast?	N/A
N/A	Landing Slope (%)	N/A	N/A	DWS Length (in)	N/A
N/A	Landing X Slope (%)	N/A	N/A	DWS Full Width?	N/A
N/A	Landing Curb? (Y/N)	N/A	N/A	DWS Offset (in)	N/A
N/A	Shared Landing?	N/A			
N/A	Gutter Ponding?	N/A	N/A	Gutter Slope (%)	N/A
N/A	Gutter Lip Ht (in)	N/A	N/A	Gutter X Slope (%)	N/A
N/A	Painted X Walk1?	No	N/A	Painted X Walk2?	No
	X Walk 1 Direction	To NW		X Walk 2 Direction	To SW
N/A	X Walk 1 Width (in)	N/A	N/A	X Walk 2 Width (in)	N/A
	X Walk 1 Slope (%)	5.8		X Walk 2 Slope (%)	1.7
	X Walk 1 X Slope (%)	0.7		X Walk 2 X Slope (%)	5.3

N/A	Ramp inside XWalk1?	N/A	N/A	Ramp inside XWalk2?	N/A
	Road Slope (%)	5.6	N/A	Clear Space?	N/A
	Road X Slope (%)	3.8	N/A	Clear Space to XWalk (in)	N/A
N/A	Any Obstructions?	N/A	N/A	Storm Grate/Utility Hazard?	N/A
	Obstruction Type			Storm Grate/Utility Type	
		N/A			N/A
		Yes		Surface Condition? (G/P)	Good

Remove & Replace Curb Ramp With Two New Directional Ramps or Equivalent.

Total Cost: \$ 3200.00
