Access Compliance Report Public Rights-of-Way (Curb Ramps)

Intersection ID: 11994 Main Street: BELVEDERE_AV Cross Street: THE_PLAZA Location: NW **Overall Compliance: No ADA ID: BA48583EDC8B** Ramp Type: Perp Initial Pass/Fail: Fail **Severity Score:** 12.5

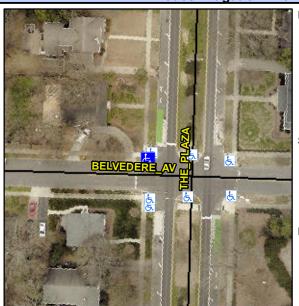
Comp	liance Description	Data	Comp	liance	Description	Data
N/A	Ramp Length (in)	68.0	No	Ramp	Slope (%)	9.3
Yes	Ramp Width (in)	49.0	Yes	Yes Ramp XSlope (%)		1.1
N/A	Flare Type LT	N/A	N/A	N/A Flare Type RT		N/A
N/A	Flare Slope LT (%)	N/A	N/A	N/A Flare Slope RT (%)		N/A
N/A	Flare Traversable LT?	N/A	N/A	N/A Flare Traversable RT?		N/A
N/A	Landing Length (in)	N/A	N/A	DWS	Provided?	N/A
N/A	Landing Width (in)	N/A	N/A	DWS	Contrast?	N/A
N/A	Landing Slope (%)	N/A	N/A	DWS	Length (in)	N/A
N/A	Landing X Slope (%)	N/A	N/A	DWS	Full Width?	N/A
N/A	Landing Curb? (Y/N)	N/A	N/A	DWS	Offset (in)	N/A
N/A	Shared Landing?	N/A				
N/A	Gutter Ponding?	N/A	N/A	Gutte	r Slope (%)	N/A
N/A	Gutter Lip Ht (in)	N/A	N/A	Gutte	r X Slope (%)	N/A
N/A	Painted X Walk1?	Yes	N/A	Paint	ed X Walk2?	N/A
	X Walk 1 Direction	To S		X Wa	lk 2 Direction	N/A
N/A	X Walk 1 Width (in)	114.0	N/A	X Wa	lk 2 Width (in)	N/A
	X Walk 1 Slope (%)	2.0		X Wa	lk 2 Slope (%)	N/A

X Walk 1 X Slope (%)	2.8		X Wa	lk 2 X Slope (%)	N/A
N/A	Ramp inside XWalk1?	Yes	N/A	Ramp	inside XWalk2?	N/A
	Road Slope (%)	N/A	N/A	Clear	Space?	N/A
	Road X Slope (%)	N/A	N/A	Clear	Space to XWalk (in)	N/A
N/A	Any Obstructions?	N/A	N/A	Storm	n Grate/Utility Hazard?	N/A
	Obstruction Type			Storm	n Grate/Utility Type	
		N/A				N/A
			Yes	Surfa	ce Condition? (G/P)	Good

Possible Solution	
Possible Solutions:	Con
Remove & Replace Entire Ramp.	N/A
·	Yes
	N/A
	N/A
	N/A
	N/A
Surveyor Notes:	N/A
N/A	N/A
	N/A
	N/A
	N/A
PROW/ADA:	N/A
Not Found, R304.2.2	N/A
,	N/A
	N/A
	N/A
