Access Compliance Report

Public Rights-of-Way

(Curb Ramps)

Intersection ID: 25775	Main Street: CARMEL_RD	Cross Street: PINEVILLE-MATTHEWS_RD	Location: SW
ADA ID: BA48D1C4A99E	Ramp Type: IslandPerp	Initial Pass/Fail: Fail	Overall Compliance: No
Severity Score: 21.25			
Codes/Mitigation Info/Possible Solution		Field Measurements/Component Compliance

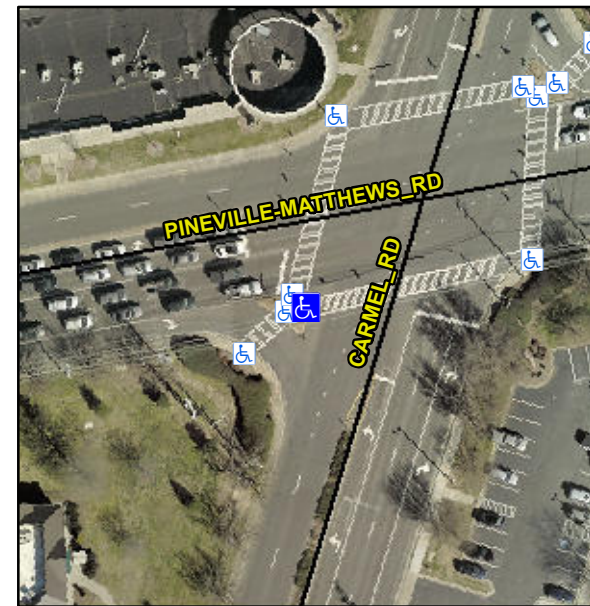
Not Found, R304.5.1, R304.5.3

Compliance	Description	Data	Compliance	Description	Data
N/A	Ramp Length (in)	88.0	Yes	Ramp Slope (%)	6.9
No	Ramp Width (in)	36.0	No	Ramp XSlope (%)	5.4
N/A	Flare Type LT	N/A	N/A	Flare Type RT	N/A
N/A	Flare Slope LT (%)	N/A	N/A	Flare Slope RT (%)	N/A
N/A	Flare Traversable LT?	N/A	N/A	Flare Traversable RT?	N/A
N/A	Landing Length (in)	N/A	N/A	DWS Provided?	N/A
N/A	Landing Width (in)	N/A	N/A	DWS Contrast?	N/A
N/A	Landing Slope (%)	N/A	N/A	DWS Length (in)	N/A
N/A	Landing X Slope (%)	N/A	N/A	DWS Full Width?	N/A
N/A	Landing Curb? (Y/N)	N/A	N/A	DWS Offset (in)	N/A
N/A	Shared Landing?	N/A			
N/A	Gutter Ponding?	N/A	N/A	Gutter Slope (%)	N/A
N/A	Gutter Lip Ht (in)	N/A	N/A	Gutter X Slope (%)	N/A
N/A	Painted X Walk1?	Yes	N/A	Painted X Walk2?	N/A
	X Walk 1 Direction	To E		X Walk 2 Direction	N/A
N/A	X Walk 1 Width (in)	112.5	N/A	X Walk 2 Width (in)	N/A
	X Walk 1 Slope (%)	3.5		X Walk 2 Slope (%)	N/A
	X Walk 1 X Slope (%)	3.1		X Walk 2 X Slope (%)	N/A

N/A	Ramp inside XWalk1?	Yes	N/A	Ramp inside XWalk2?	N/A
	Road Slope (%)	N/A	N/A	Clear Space?	N/A
	Road X Slope (%)	N/A	N/A	Clear Space to XWalk (in)	N/A
N/A	Any Obstructions?	N/A	N/A	Storm Grate/Utility Hazard?	N/A
	Obstruction Type			Storm Grate/Utility Type	
		N/A			N/A
		Yes		Surface Condition? (G/P)	Good

Possible Solutions:

Remove & Replace Entire Ramp.
