# Access Compliance Report

## Public Rights-of-Way

| Intersection ID: 24112 | Main Street: CARMEL_RD | Cross Street: CARMEL_VALLEY_RD | Location: SE |
| ADA ID: BA4A35E3E0D2 | Ramp Type: Perp | Initial Pass/Fail: Fail | Overall Compliance: No |

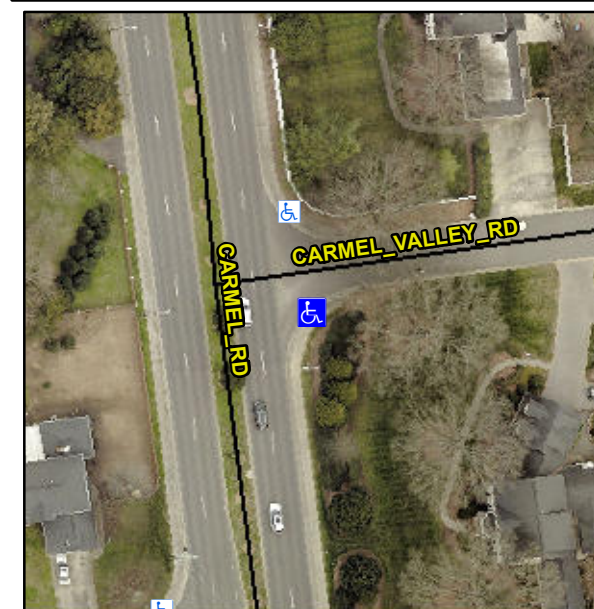
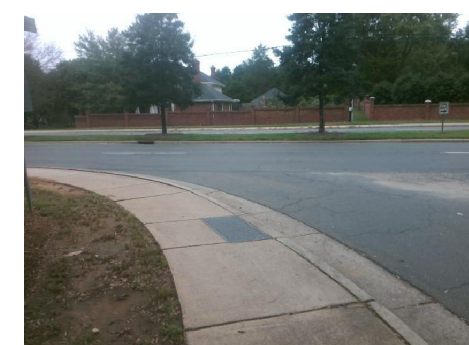
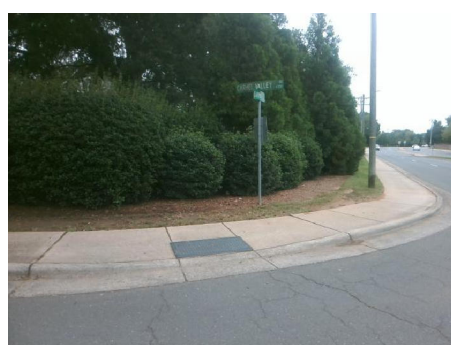
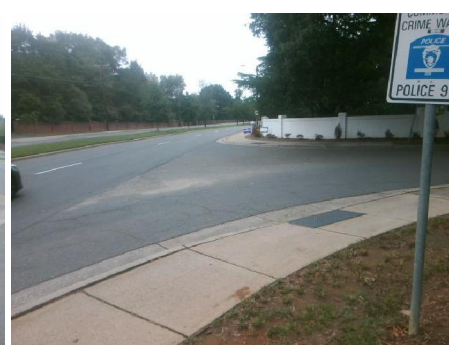
| Severity Score: 33.75 | | | |

**Not Found, R304.5.1, R304.2.2**

| Compliance | Description | Data | Compliance | Description | Data |
|---|---|---|---|---|---|
| N/A | Ramp Length (in) | 59.0 | No | Ramp Slope (%) | 13.4 |
| No | Ramp Width (in) | 43.0 | Yes | Ramp XSlope (%) | 1.8 |

**Remove & Replace Entire Ramp.**

Total Cost: \$ 1850.00
