# Access Compliance Report

## Public Rights-of-Way

### (Curb Ramps)

| Intersection ID: 24170 | Main Street: CARMEL_RD | Cross Street: FOXMOOR_DR | Location: NW |

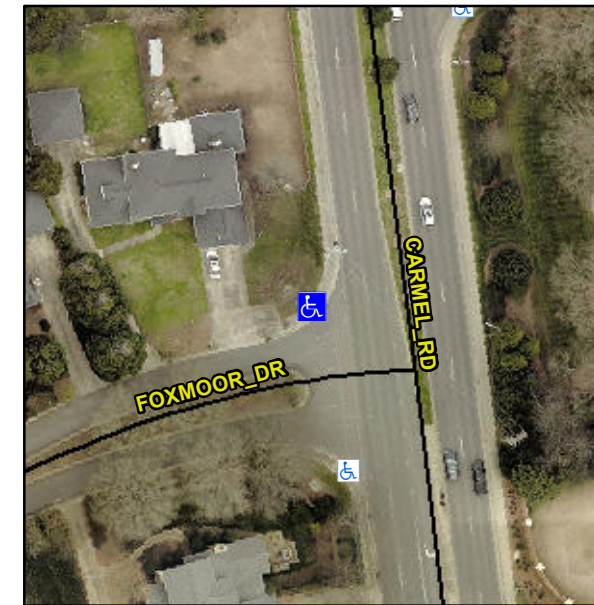
| ADA ID: BA4EA94AD43E | Ramp Type: Perp | Initial Pass/Fail: Fail | Overall Compliance: No |

**Not Found, R304.5.1, R304.5.3**

| Compliance | Description | Data | Compliance | Description | Data |
|---|---|---|---|---|---|
| No | Ramp Width (in) | 39.5 | No | Ramp XSlope (%) | 4.6 |

**Remove & Replace Entire Ramp.**

Total Cost: \$ 1850.00
