Intersection ID: 53212	Main Street: IDLEWILD_RD	Cross Street: E_INDEPENDENCE_RA	Location:	SW
ADA ID: BA5A7451F576	Ramp Type: Perp	Initial Pass/Fail: Fail	Overall Compliance: No	Severity Score: 13.75

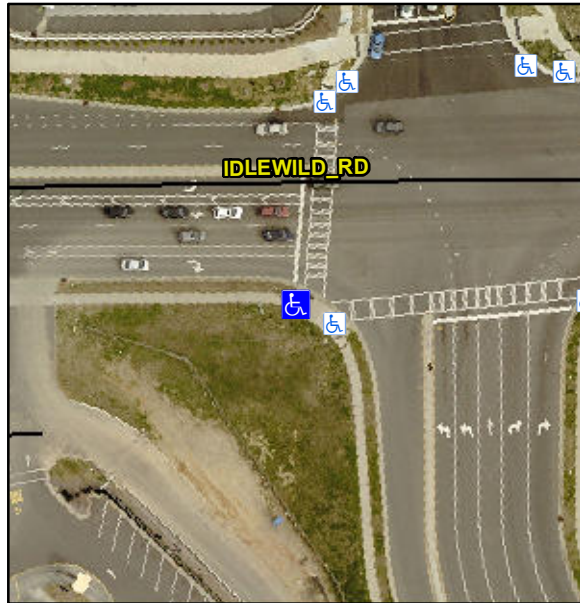
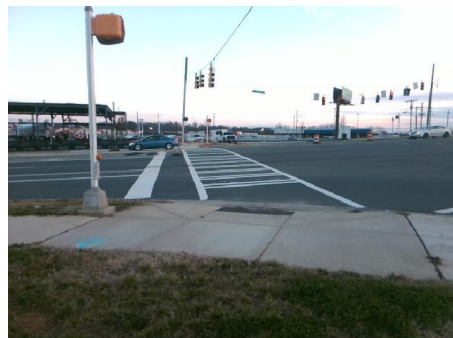
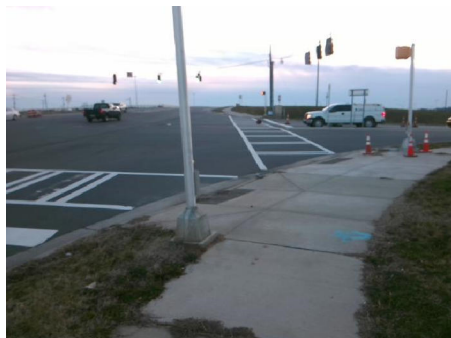
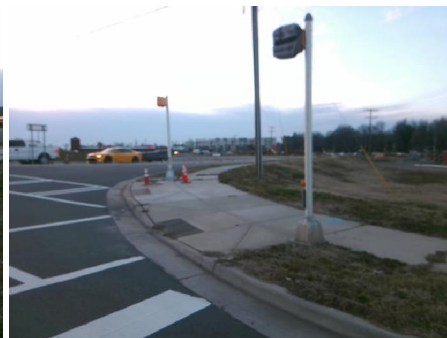
R304.2.2

Compliance	Description	Data	Compliance	Description	Data
N/A	Ramp Length (in)	66.0	No	Ramp Slope (%)	10.6
Yes	Ramp Width (in)	59.0	Yes	Ramp XSlope (%)	2.6
N/A	Flare Type LT	N/A	N/A	Flare Type RT	N/A
N/A	Flare Slope LT (%)	N/A	N/A	Flare Slope RT (%)	N/A
N/A	Flare Traversable LT?	N/A	N/A	Flare Traversable RT?	N/A
N/A	Landing Length (in)	N/A	N/A	DWS Provided?	N/A
N/A	Landing Width (in)	N/A	N/A	DWS Contrast?	N/A
N/A	Landing Slope (%)	N/A	N/A	DWS Length (in)	N/A
N/A	Landing X Slope (%)	N/A	N/A	DWS Full Width?	N/A
N/A	Landing Curb? (Y/N)	N/A	N/A	DWS Offset (in)	N/A
N/A	Shared Landing?	N/A			
N/A	Gutter Ponding?	N/A	N/A	Gutter Slope (%)	N/A
N/A	Gutter Lip Ht (in)	N/A	N/A	Gutter X Slope (%)	N/A
N/A	Painted X Walk1?	Yes	N/A	Painted X Walk2?	N/A
	X Walk 1 Direction	To N		X Walk 2 Direction	N/A
N/A	X Walk 1 Width (in)	112.0	N/A	X Walk 2 Width (in)	N/A
	X Walk 1 Slope (%)	3.5		X Walk 2 Slope (%)	N/A
	X Walk 1 X Slope (%)	3.9		X Walk 2 X Slope (%)	N/A

N/A	Ramp inside XWalk1?	Yes	N/A	Ramp inside XWalk2?	N/A
	Road Slope (%)	N/A	N/A	Clear Space?	N/A
	Road X Slope (%)	N/A	N/A	Clear Space to XWalk (in)	N/A
N/A	Any Obstructions?	N/A	N/A	Storm Grate/Utility Hazard?	N/A
	Obstruction Type			Storm Grate/Utility Type	
		N/A			N/A
			Yes	Surface Condition? (G/P)	Good

Possible Solutions:

Remove & Replace Entire Ramp.
