Access Compliance Report

Public Rights-of-Way

(Curb Ramps)

Intersection ID: 53165	Main Street: DIXIE_RIVER_RD	Cross Street: N/A	Location: SE
ADA ID: BA5CE36B5EA5	Ramp Type: Perp	Initial Pass/Fail: Fail	Overall Compliance: No
Severity Score: 21.25			
Codes/Mitigation Info/Possible Solution		Field Measurements/Component Compliance

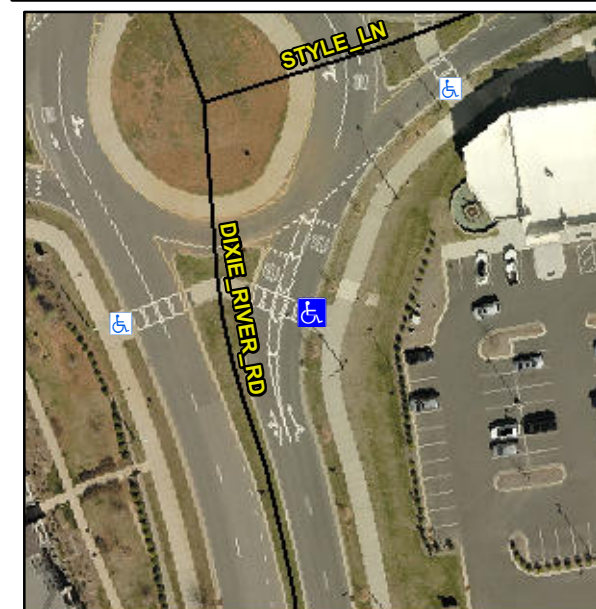
Not Found, R304.5.1, R304.5.3

Compliance	Description	Data	Compliance	Description	Data
N/A	Ramp Length (in)	96.0	Yes	Ramp Slope (%)	6.4
No	Ramp Width (in)	47.0	No	Ramp XSlope (%)	6.4
N/A	Flare Type LT	N/A	N/A	Flare Type RT	N/A
N/A	Flare Slope LT (%)	N/A	N/A	Flare Slope RT (%)	N/A
N/A	Flare Traversable LT?	N/A	N/A	Flare Traversable RT?	N/A
N/A	Landing Length (in)	N/A	N/A	DWS Provided?	N/A
N/A	Landing Width (in)	N/A	N/A	DWS Contrast?	N/A
N/A	Landing Slope (%)	N/A	N/A	DWS Length (in)	N/A
N/A	Landing X Slope (%)	N/A	N/A	DWS Full Width?	N/A
N/A	Landing Curb? (Y/N)	N/A	N/A	DWS Offset (in)	N/A
N/A	Shared Landing?	N/A			
N/A	Gutter Ponding?	N/A	N/A	Gutter Slope (%)	N/A
N/A	Gutter Lip Ht (in)	N/A	N/A	Gutter X Slope (%)	N/A
N/A	Painted X Walk1?	Yes	N/A	Painted X Walk2?	N/A
	X Walk 1 Direction	To NW		X Walk 2 Direction	N/A
N/A	X Walk 1 Width (in)	111.0	N/A	X Walk 2 Width (in)	N/A
	X Walk 1 Slope (%)	5.6		X Walk 2 Slope (%)	N/A
	X Walk 1 X Slope (%)	5.6		X Walk 2 X Slope (%)	N/A

N/A	Ramp inside XWalk1?	Yes	N/A	Ramp inside XWalk2?	N/A
	Road Slope (%)	N/A	N/A	Clear Space?	N/A
	Road X Slope (%)	N/A	N/A	Clear Space to XWalk (in)	N/A
N/A	Any Obstructions?	N/A	N/A	Storm Grate/Utility Hazard?	N/A
	Obstruction Type			Storm Grate/Utility Type	
		N/A			N/A
			Yes	Surface Condition? (G/P)	Good

Remove & Replace Entire Ramp.
