## Access Compliance Report Public Rights-of-Way (Curb Ramps)

Intersection ID: 11330Main Street: FLAMINGO\_AVCross Street: PALM\_AVLocation:NEADA ID: BA697503E4F8Ramp Type: PerpInitial Pass/Fail: FailOverall Compliance: NoSeverity Score:10

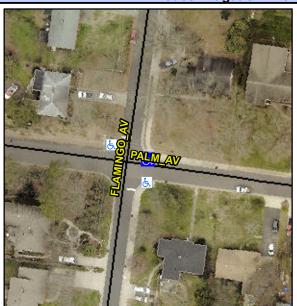
Field Measurements/Component Compliance								
Compliance Description		Data	Compliance Description		Data			
N/A	Ramp Length (in)	67.0	Yes	Ramp Slope (%)	7.5			
No	Ramp Width (in)	36.5	No	Ramp XSlope (%)	2.3			
N/A	Flare Type LT	N/A	N/A	Flare Type RT	N/A			
N/A	Flare Slope LT (%)	N/A	N/A	Flare Slope RT (%)	N/A			
N/A	Flare Traversable LT?	N/A	N/A	Flare Traversable RT?	N/A			
N/A	Landing Length (in)	N/A	N/A	DWS Provided?	N/A			
N/A	Landing Width (in)	N/A	N/A	DWS Contrast?	N/A			
N/A	Landing Slope (%)	N/A	N/A	DWS Length (in)	N/A			
N/A	Landing X Slope (%)	N/A	N/A	DWS Full Width?	N/A			
N/A	Landing Curb? (Y/N)	N/A	N/A	DWS Offset (in)	N/A			
N/A	Shared Landing?	N/A						
N/A	Gutter Ponding?	N/A	N/A	Gutter Slope (%)	N/A			
N/A	Gutter Lip Ht (in)	N/A	N/A	Gutter X Slope (%)	N/A			
N/A	Painted X Walk1?	No	N/A	Painted X Walk2?	N/A			
	X Walk 1 Direction	To S		X Walk 2 Direction	N/A			
N/A	X Walk 1 Width (in)	N/A	N/A	X Walk 2 Width (in)	N/A

X Walk 1 Slope (%)	1.2		X Walk 2 Slope (%)	N/A			
	X Walk 1 X Slope (%)	2.1		X Walk 2 X Slope (%)	N/A			
N/A	Ramp inside XWalk1?	N/A	N/A	Ramp inside XWalk2?	N/A			
	Road Slope (%)	N/A	N/A	Clear Space?	N/A			
	Road X Slope (%)	N/A	N/A	Clear Space to XWalk (in)	N/A			
N/A	Any Obstructions?	N/A	N/A	Storm Grate/Utility Hazard?	N/A			
	Obstruction Type			Storm Grate/Utility Type				
		N/A			N/A			
			Yes	Surface Condition? (G/P)	Good

1	Possible Solutions:	<u>c</u>
	Remove & Replace Entire Ramp.	N
ı.	•	N
-		N/
		N
,		N
		N
	Surveyor Notes:	N
360	N/A	N
		N
		N
P.		N
1	PROW/ADA:	N
100	Not Found, R304.5.1, R304.5.3	N/
	,	N
è		
1		N
		N
