Access Compliance Report Public Rights-of-Way (Curb Ramps)

Main Street: E 10TH ST Cross Street: N/A Location: S Intersection ID: 10014773 Ramp Type: Combination1 Initial Pass/Fail: Pass **Overall Compliance: No Severity Score:** 15

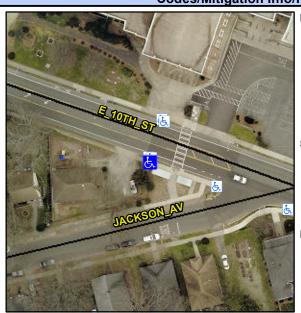
Landing Curb? (Y/N)	No	Yes	DWS Offset (in)	0.0
	Shared Landing?	No			
	Gutter Ponding?	Yes	No	Gutter Slope (%)	20.5
;	Gutter Lip Ht (in)	0.0	Yes	Gutter X Slope (%)	0.2
	Painted X Walk1?	Yes	N/A	Painted X Walk2?	N/A
	X Walk 1 Direction	To N		X Walk 2 Direction	N/A
	X Walk 1 Width (in)	112.0		X Walk 2 Width (in)	N/A
	X Walk 1 Slope (%)	2.6		X Walk 2 Slope (%)	N/A
	X Walk 1 X Slope (%)	1.2		X Walk 2 X Slope (%)	N/A
•	Ramp inside XWalk1?	Yes	N/A	Ramp inside XWalk2?	N/A
	Road Slope (%)	N/A		Clear Space?	Yes
	Road X Slope (%)	N/A	N/A	Clear Space to XWalk (in)	N/A
	Will have be		Yes	Any Obstruction?	No
II.				Obstruction Type	
					N/A
			Yes	Storm Grate/Utility Hazard?	No
1				Storm Grate/Utility Type	
-E-	The state of the s				N/A
			Yes	Surface Condition? (G/P)	Good
				Curb Slope (%)	7.4

Possible Solution
Possible Solutions:
Remove & Replace Entire Ramp. Remove & Replace Gutter.
Surveyor Notes:
RT RP < 5%
PROW/ADA:
Not Found, R304.2.1, R304.2.2-Perp, R304.3.2-Para, R304.5.3, R302.7, R304.5.4
