## **Access Compliance Report Public Rights-of-Way** (Curb Ramps)

Intersection ID: 12114 Main Street: ROBINSON\_CHURCH\_RD Cross Street: TEANECK\_PL Location: SE **Overall Compliance: No** ADA ID: BA7C13005404 Ramp Type: Perp Initial Pass/Fail: Fail **Severity Score:** 25

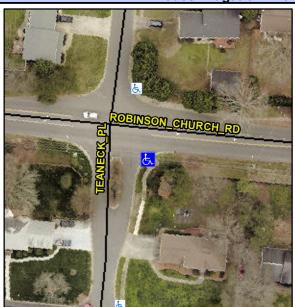
Field Measurements/Component Compliance							
Compl	iance Description	Data	Comp	liance Description	Data		
N/A	Ramp Length (in)	60.0	Yes	Ramp Slope (%)	7.2		
Yes	Ramp Width (in)	51.0	No	Ramp XSlope (%)	7.3		
N/A	Flare Type LT	N/A	N/A	Flare Type RT	N/A		
N/A	Flare Slope LT (%)	N/A	N/A	Flare Slope RT (%)	N/A		
N/A	Flare Traversable LT?	N/A	N/A	Flare Traversable RT?	N/A		
N/A	Landing Length (in)	N/A	N/A	DWS Provided?	N/A		
N/A	Landing Width (in)	N/A	N/A	DWS Contrast?	N/A		
N/A	Landing Slope (%)	N/A	N/A	DWS Length (in)	N/A		
N/A	Landing X Slope (%)	N/A	N/A	DWS Full Width?	N/A		
N/A	Landing Curb? (Y/N)	N/A	N/A	DWS Offset (in)	N/A		
N/A	Shared Landing?	N/A					
N/A	Gutter Ponding?	N/A	N/A	Gutter Slope (%)	N/A		
N/A	Gutter Lip Ht (in)	1.0	N/A	Gutter X Slope (%)	N/A		
N/A	Painted X Walk1?	No	N/A	Painted X Walk2?	N/A		
	X Walk 1 Direction	To N		X Walk 2 Direction	N/A		
N/A	X Walk 1 Width (in)	N/A	N/A	X Walk 2 Width (in)	N/A

X Walk 1 Slope (%)	4.2		X Walk 2 Slope (%)	N/A		
	X Walk 1 X Slope (%)	6.0		X Walk 2 X Slope (%)	N/A		
N/A	Ramp inside XWalk1?	N/A	N/A	Ramp inside XWalk2?	N/A		
	Road Slope (%)	N/A	N/A	Clear Space?	N/A		
	Road X Slope (%)	N/A	N/A	Clear Space to XWalk (in)	N/A		
N/A	Any Obstructions?	N/A	N/A	Storm Grate/Utility Hazard?	N/A		
	Obstruction Type			Storm Grate/Utility Type			
		N/A			N/A		
			Yes	Surface Condition? (G/P)	Good

1 Ossible Solution		
Possible Solutions:	Compliance	
Remove & Replace Entire Ramp.	N/A	Ra
	Yes	Ra
	N/A	Fla
	N/A	Fla
	N/A	Fla
	N/A	Laı
Surveyor Notes:	N/A	Laı
N/A	N/A	Laı
	N/A	Laı
	N/A	Laı
	N/A	Sh
PROW/ADA:	N/A	Gu
Not Found, R304.5.3	N/A	Gu
	N/A	Pai
		ΧV
	N/A	X۷
		ΧV
		ΧV
	N/A	Ra
		Ro
		Ro

1850.00
