Access Compliance Report

Public Rights-of-Way

(Curb Ramps)

Intersection ID: 15351	Main Street: BARRINGER_DR	Cross Street: CLANTON_RD	Location: SW
ADA ID: BA9B1802913F	Ramp Type: PerpDiag	Initial Pass/Fail: Fail	Overall Compliance: No
		Severity Score: 12.5

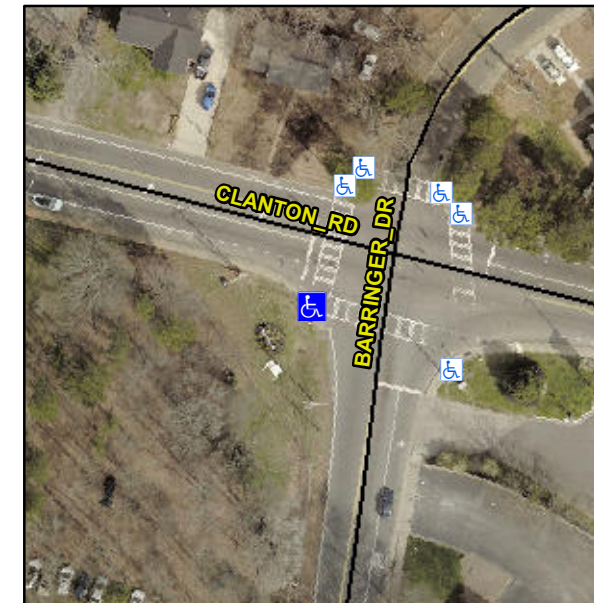
Not Found, R304.2.2

Compliance	Description	Data	Compliance	Description	Data
N/A	Ramp Length (in)	60.0	No	Ramp Slope (%)	8.5
Yes	Ramp Width (in)	48.0	Yes	Ramp XSlope (%)	1.4
N/A	Flare Type LT	N/A	N/A	Flare Type RT	N/A
N/A	Flare Slope LT (%)	N/A	N/A	Flare Slope RT (%)	N/A
N/A	Flare Traversable LT?	N/A	N/A	Flare Traversable RT?	N/A
N/A	Landing Length (in)	N/A	N/A	DWS Provided?	N/A
N/A	Landing Width (in)	N/A	N/A	DWS Contrast?	N/A
N/A	Landing Slope (%)	N/A	N/A	DWS Length (in)	N/A
N/A	Landing X Slope (%)	N/A	N/A	DWS Full Width?	N/A
N/A	Landing Curb? (Y/N)	N/A	N/A	DWS Offset (in)	N/A
N/A	Shared Landing?	N/A			
N/A	Gutter Ponding?	N/A	N/A	Gutter Slope (%)	N/A
N/A	Gutter Lip Ht (in)	N/A	N/A	Gutter X Slope (%)	N/A
N/A	Painted X Walk1?	Yes	N/A	Painted X Walk2?	Yes
	X Walk 1 Direction	To SE		X Walk 2 Direction	To N
N/A	X Walk 1 Width (in)	122.0	N/A	X Walk 2 Width (in)	110.0
	X Walk 1 Slope (%)	4.9		X Walk 2 Slope (%)	3.6
	X Walk 1 X Slope (%)	3.0		X Walk 2 X Slope (%)	5.5

N/A	Ramp inside XWalk1?	Yes	N/A	Ramp inside XWalk2?	Yes
	Road Slope (%)	1.4	N/A	Clear Space?	N/A
	Road X Slope (%)	3.8	N/A	Clear Space to XWalk (in)	N/A
N/A	Any Obstructions?	N/A	N/A	Storm Grate/Utility Hazard?	N/A
	Obstruction Type			Storm Grate/Utility Type	
		N/A			N/A
			Yes	Surface Condition? (G/P)	Good

Remove & Replace Curb Ramp With Two New Directional Ramps or Equivalent.
