Access Compliance Report

Public Rights-of-Way

(Curb Ramps)

Intersection ID: 48555	Main Street: COTTON_PRESS_RD	Cross Street: RIDGEFOREST_DR	Location: NW
ADA ID: BAA381235156	Ramp Type: Combination1Diag	Initial Pass/Fail: Fail	Overall Compliance: No
Codes/Mitigation Info/Possible Solution		Field Measurements/Component Compliance	
Severity Score: 0

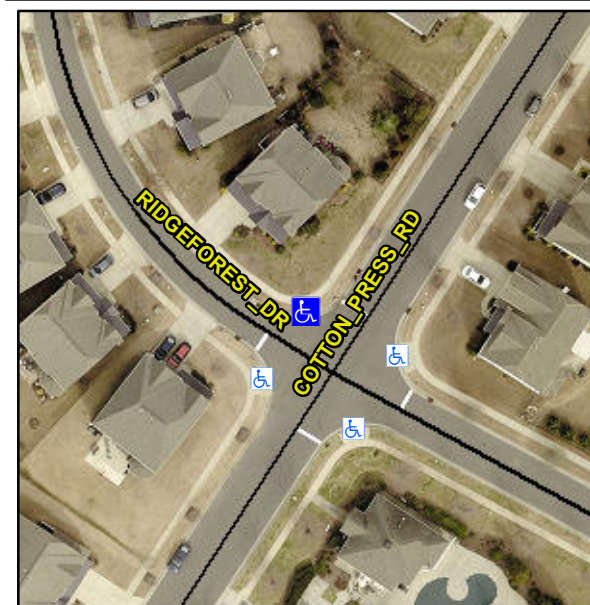
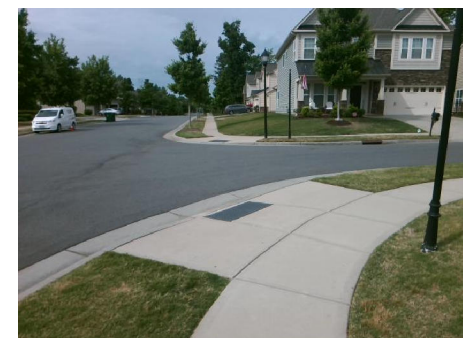
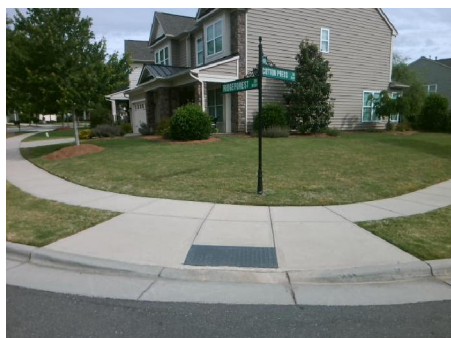
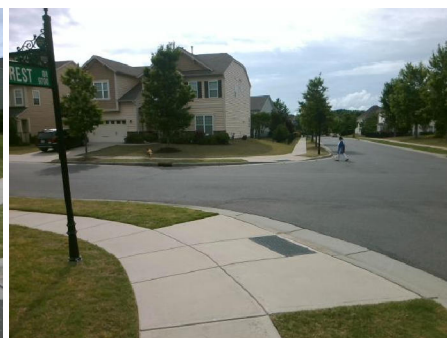
RT RP < 5%

Not Found, R304.5.1, R304.5.1, R304.2.2, R304.5.3

Compliance	Description	Data	Compliance	Description	Data
N/A	Ramp Length LT (in)	47.0	N/A	Ramp Length RT (in)	46.0
No	Ramp Width LT (in)	47.0	No	Ramp Width RT (in)	45.0
Yes	Ramp Slope LT (%)	5.7	Yes	Ramp Slope RT (%)	3.1
No	Ramp XSlope LT (%)	2.6	Yes	Ramp XSlope RT (%)	1.5
N/A	Ramp Length (in)	72.0	No	Ramp Slope (%)	9.0
No	Ramp Width (in)	46.0	No	Ramp XSlope (%)	3.5
N/A	Flare Type LT	N/A	N/A	Flare Type RT	N/A
N/A	Flare Slope LT (%)	N/A	N/A	Flare Slope RT (%)	N/A
N/A	Flare Traversable LT?	N/A	N/A	Flare Traversable RT?	N/A
N/A	Landing Length (in)	N/A	N/A	DWS Provided?	N/A
N/A	Landing Width (in)	N/A	N/A	DWS Contrast?	N/A
N/A	Landing Slope (%)	N/A	N/A	DWS Length (in)	N/A
N/A	Landing X Slope (%)	N/A	N/A	DWS Full Width?	N/A
N/A	Landing Curb? (Y/N)	N/A	N/A	DWS Offset (in)	N/A
N/A	Shared Landing?	N/A			
N/A	Gutter Ponding?	N/A	N/A	Gutter Slope (%)	N/A
N/A	Gutter Lip Ht (in)	N/A	N/A	Gutter X Slope (%)	N/A
N/A	Painted X Walk1?	No	N/A	Painted X Walk2?	No

X Walk 1 Direction	To SW		X Walk 2 Direction	To SE
	X Walk 1 Width (in)	N/A		X Walk 2 Width (in)	N/A
	X Walk 1 Slope (%)	1.8		X Walk 2 Slope (%)	0.4
	X Walk 1 X Slope (%)	2.6		X Walk 2 X Slope (%)	0.4
N/A	Ramp inside XWalk1?	N/A	N/A	Ramp inside XWalk2?	N/A
	Road Slope (%)	1.1		Clear Space?	N/A
	Road X Slope (%)	1.5	N/A	Clear Space to XWalk (in)	N/A
			N/A	Any Obstruction?	N/A
				Obstruction Type	N/A
			N/A	Storm Grate/Utility Hazard?	N/A
				Storm Grate/Utility Type	N/A
			Yes	Surface Condition? (G/P)	Good
				Curb Slope (%)	16.7

Possible Solutions:

Remove & Replace Curb Ramp With Two New Directional Ramps or Equivalent.

Total Cost: \$ 3200.00
