# Access Compliance Report

## Public Rights-of-Way

### (Curb Ramps)

Intersection ID: 11016	Main Street: AMBASSADOR_ST	Cross Street: TUCKASEEGEE_RD	Location: S
ADA ID: BAA4845CB6C4	Ramp Type: Directional1	Initial Pass/Fail: Fail	Overall Compliance: No
			Severity Score: 33.75

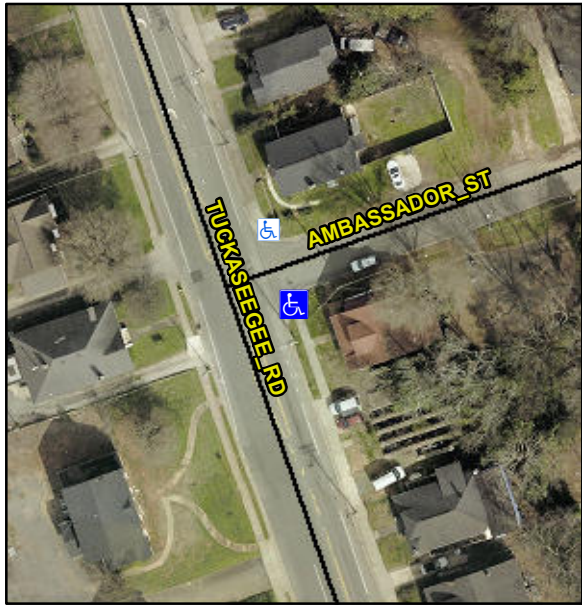
Possible Solutions:		Compliance	Description	Data	Compliance	Description	Data
	Remove & Replace Entire Ramp.		N/A	Ramp Length (in)	73.0	N/A	Grade Break?	N/A
			No	Ramp Width (in)	47.5	N/A	Grade Break Slope (%)	0.0
			No	Ramp Slope (%)	15.6	N/A	Grade Break XSlope (%)	0.0
			Yes	Ramp XSlope (%)	0.6			
			N/A	Flare Type LT	N/A	N/A	Flare Type RT	N/A
			N/A	Flare Slope LT (%)	N/A	N/A	Flare Slope RT (%)	0.0
			N/A	Flare Traversable LT?	N/A	N/A	Flare Traversable RT?	N/A
			N/A	Landing Length (in)	0.0	N/A	DWS Provided?	N/A
			N/A	Landing Width (in)	0.0	N/A	DWS Contrast?	N/A
Surveyor Notes:			N/A	Landing Slope (%)	0.0	N/A	DWS Length (in)	N/A
N/A			N/A	Landing X Slope (%)	0.0	N/A	DWS Full Width?	N/A
PROW/ADA:			N/A	Landing Curb? (Y/N)	N/A	N/A	DWS Offset LT (in)	N/A
R304.5.1, R304.2.2			N/A	Shared Landing?	N/A	N/A	DWS Offset RT (in)	N/A

N/A	Gutter Ponding?	0.0	N/A	Gutter Slope (%)	N/A
			N/A	Gutter Lip Ht (in)	0.0	N/A	Gutter X Slope (%)	N/A
			N/A	Painted X Walk1?	No		Road Slope (%)	5.1
				X Walk 1 Direction	To N		Road X Slope (%)	12.2
				X Walk 1 Width (in)	N/A		Clear Space?	N/A
				X Walk 1 Slope (%)	5.1	N/A	Clear Space to XWalk (in)	N/A
				X Walk 1 X Slope (%)	12.2	N/A	Storm Grate/Utility Hazard?	N/A
			N/A	Ramp inside XWalk1?	N/A		Storm Grate/Utility Type	
			N/A	Any Obstructions?	N/A			N/A
				Obstruction Type		Yes	Surface Condition? (G/P)	Good
					N/A	N/A	Curb Slope (%)	15.5
Total Cost:		\$	1600.00
