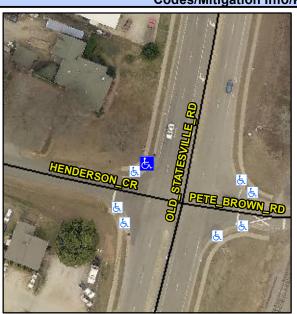
1850.00

Field Measurements/Component Compliance							
Compliance Description		Data	Comp	iance Desc	ription	Data	
N/A	Ramp Length (in)	60.5	No	lo Ramp Slope (%)		14.8	
No	Ramp Width (in)	31.0	No	Ramp XSlope (%)		4.9	
N/A	Flare Type LT	N/A	N/A	Flare Type RT		N/A	
N/A	Flare Slope LT (%)	N/A	N/A	Flare Slope RT (%)		N/A	
N/A	Flare Traversable LT?	N/A	N/A	Flare Traversable RT?		N/A	
N/A	Landing Length (in)	N/A	N/A	DWS Provided?		N/A	
N/A	Landing Width (in)	N/A	N/A	DWS Contrast?		N/A	
N/A	Landing Slope (%)	N/A	N/A	DWS Length (in)		N/A	
N/A	Landing X Slope (%)	N/A	N/A	DWS Full Width?		N/A	
N/A	Landing Curb? (Y/N)	N/A	N/A	DWS Offset (in)		N/A	
N/A	Shared Landing?	N/A					
N/A	Gutter Ponding?	N/A	N/A	Gutter Slope (%)		N/A	
N/A	Gutter Lip Ht (in)	N/A	N/A	Gutter X Slope (%)		N/A	
N/A	Painted X Walk1?	No	N/A	Painted X Walk2?		N/A	
	X Walk 1 Direction	То Е		X Walk 2 Di	rection	N/A	
N/A	X Walk 1 Width (in)	N/A	N/A	X Walk 2 W	idth (in)	N/A

OLD STATESVILLE RD Street 1 Name Stop Condition-Street 2 None Street 2 Name N/A Stop Condition-Street 1 N/A
