Access Compliance Report

Public Rights-of-Way

(Curb Ramps)

Intersection ID: 46815	Main Street: OLDE_IVY_WY	Cross Street: ARBOR_CREST_CT	Location: S
ADA ID: BABE573DDCE3	Ramp Type: PerpDiag	Initial Pass/Fail: Fail	Overall Compliance: No
Severity Score: 60			
Codes/Mitigation Info/Possible Solution		Field Measurements/Component Compliance

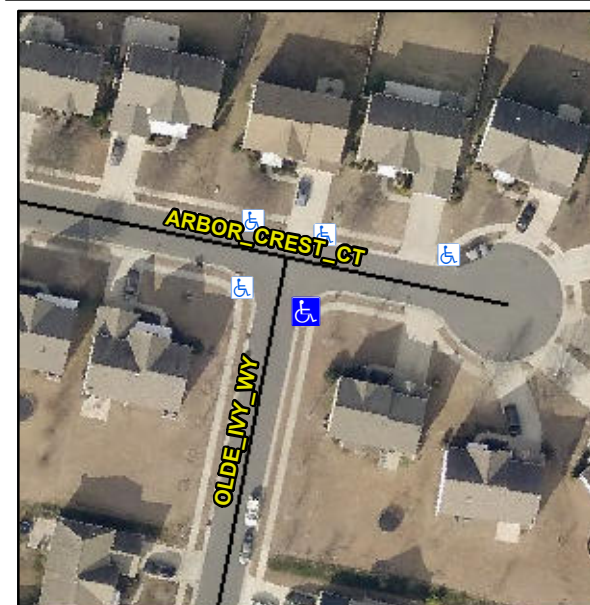
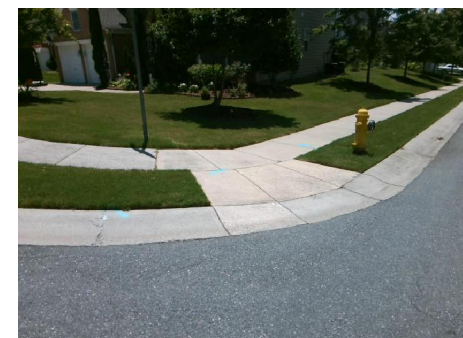
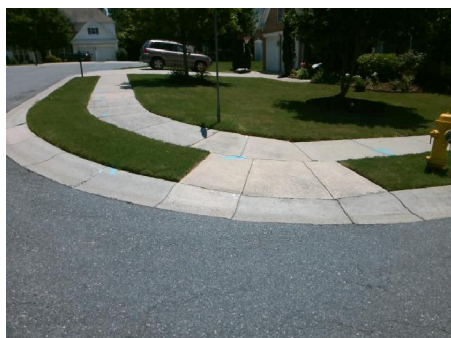
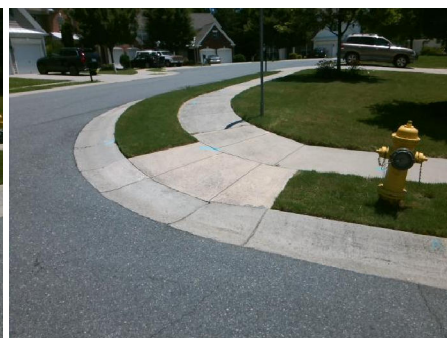
Not Found, R304.5.1, R304.2.2, R304.5.3

Compliance	Description	Data	Compliance	Description	Data
N/A	Ramp Length (in)	49.0	No	Ramp Slope (%)	10.2
No	Ramp Width (in)	29.0	No	Ramp XSlope (%)	5.9
N/A	Flare Type LT	N/A	N/A	Flare Type RT	N/A
N/A	Flare Slope LT (%)	N/A	N/A	Flare Slope RT (%)	N/A
N/A	Flare Traversable LT?	N/A	N/A	Flare Traversable RT?	N/A
N/A	Landing Length (in)	N/A	N/A	DWS Provided?	N/A
N/A	Landing Width (in)	N/A	N/A	DWS Contrast?	N/A
N/A	Landing Slope (%)	N/A	N/A	DWS Length (in)	N/A
N/A	Landing X Slope (%)	N/A	N/A	DWS Full Width?	N/A
N/A	Landing Curb? (Y/N)	N/A	N/A	DWS Offset (in)	N/A
N/A	Shared Landing?	N/A			
N/A	Gutter Ponding?	N/A	N/A	Gutter Slope (%)	N/A
N/A	Gutter Lip Ht (in)	N/A	N/A	Gutter X Slope (%)	N/A
N/A	Painted X Walk1?	No	N/A	Painted X Walk2?	No
	X Walk 1 Direction	To NE		X Walk 2 Direction	To NW
N/A	X Walk 1 Width (in)	N/A	N/A	X Walk 2 Width (in)	N/A
	X Walk 1 Slope (%)	7.0		X Walk 2 Slope (%)	2.8
	X Walk 1 X Slope (%)	2.5		X Walk 2 X Slope (%)	5.9

N/A	Ramp inside XWalk1?	N/A	N/A	Ramp inside XWalk2?	N/A
	Road Slope (%)	4.9	N/A	Clear Space?	N/A
	Road X Slope (%)	4.3	N/A	Clear Space to XWalk (in)	N/A
N/A	Any Obstructions?	N/A	N/A	Storm Grate/Utility Hazard?	N/A
	Obstruction Type			Storm Grate/Utility Type	
		N/A			N/A
			Yes	Surface Condition? (G/P)	Good

Remove & Replace Curb Ramp With Two New Directional Ramps or Equivalent.
