Access Compliance Report

Public Rights-of-Way

(Curb Ramps)

Intersection ID: 42950	Main Street: BENZIGER_CT	Cross Street: LONG_PAW_LN	Location: SE
ADA ID: BAC30FCFE50C	Ramp Type: PerpDiag	Initial Pass/Fail: Fail	Overall Compliance: No
Severity Score: 13.75			
Codes/Mitigation Info/Possible Solution		Field Measurements/Component Compliance

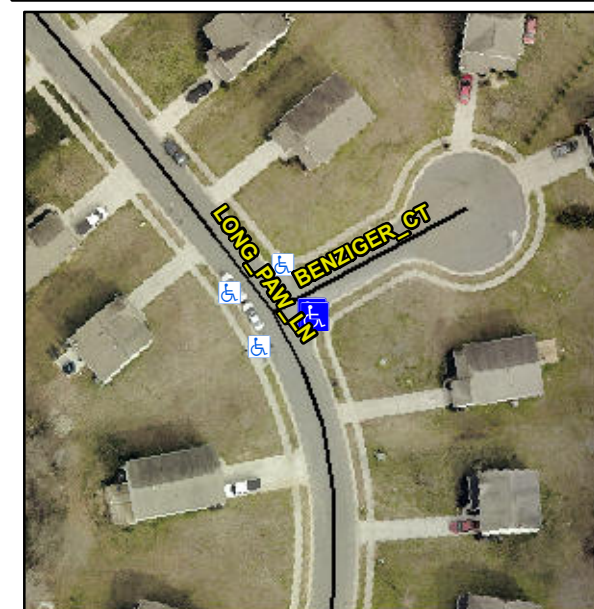
Not Found, R304.2.2, R304.5.3

Compliance	Description	Data	Compliance	Description	Data
N/A	Ramp Length (in)	48.0	No	Ramp Slope (%)	8.5
Yes	Ramp Width (in)	48.0	No	Ramp XSlope (%)	2.1
N/A	Flare Type LT	N/A	N/A	Flare Type RT	N/A
N/A	Flare Slope LT (%)	N/A	N/A	Flare Slope RT (%)	N/A
N/A	Flare Traversable LT?	N/A	N/A	Flare Traversable RT?	N/A
N/A	Landing Length (in)	N/A	N/A	DWS Provided?	N/A
N/A	Landing Width (in)	N/A	N/A	DWS Contrast?	N/A
N/A	Landing Slope (%)	N/A	N/A	DWS Length (in)	N/A
N/A	Landing X Slope (%)	N/A	N/A	DWS Full Width?	N/A
N/A	Landing Curb? (Y/N)	N/A	N/A	DWS Offset (in)	N/A
N/A	Shared Landing?	N/A			
N/A	Gutter Ponding?	N/A	N/A	Gutter Slope (%)	N/A
N/A	Gutter Lip Ht (in)	N/A	N/A	Gutter X Slope (%)	N/A
N/A	Painted X Walk1?	No	N/A	Painted X Walk2?	No
	X Walk 1 Direction	To N		X Walk 2 Direction	To W
N/A	X Walk 1 Width (in)	N/A	N/A	X Walk 2 Width (in)	N/A
	X Walk 1 Slope (%)	1.3		X Walk 2 Slope (%)	4.6
	X Walk 1 X Slope (%)	1.8		X Walk 2 X Slope (%)	1.2

N/A	Ramp inside XWalk1?	N/A	N/A	Ramp inside XWalk2?	N/A
	Road Slope (%)	1.8	N/A	Clear Space?	N/A
	Road X Slope (%)	0.4	N/A	Clear Space to XWalk (in)	N/A
N/A	Any Obstructions?	N/A	N/A	Storm Grate/Utility Hazard?	N/A
	Obstruction Type			Storm Grate/Utility Type	
		N/A			N/A
		Yes		Surface Condition? (G/P)	Good

Remove & Replace Curb Ramp With Two New Directional Ramps or Equivalent.
