Access Compliance Report

Public Rights-of-Way

(Curb Ramps)

Intersection ID: 24149	Main Street: CAROWINDS_BV	Cross Street: SOUTH_POINT_BV	Location: NW
ADA ID: BAC7991DD316	Ramp Type: Perp	Initial Pass/Fail: Fail	Overall Compliance: No
Severity Score: 12.5			
Codes/Mitigation Info/Possible Solution		Field Measurements/Component Compliance

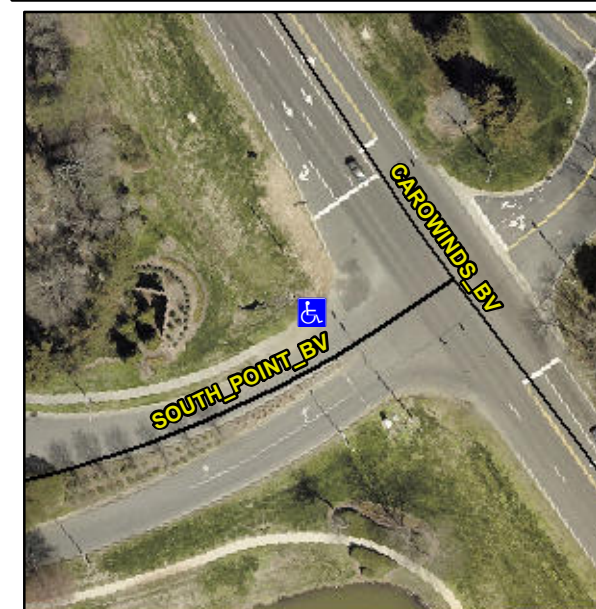
Compliance	Description	Data	Compliance	Description	Data
N/A	Ramp Length (in)	47.5	No	Ramp Slope (%)	11.1
Yes	Ramp Width (in)	48.0	Yes	Ramp XSlope (%)	1.2
N/A	Flare Type LT	N/A	N/A	Flare Type RT	N/A
N/A	Flare Slope LT (%)	N/A	N/A	Flare Slope RT (%)	N/A
N/A	Flare Traversable LT?	N/A	N/A	Flare Traversable RT?	N/A
N/A	Landing Length (in)	N/A	N/A	DWS Provided?	N/A
N/A	Landing Width (in)	N/A	N/A	DWS Contrast?	N/A
N/A	Landing Slope (%)	N/A	N/A	DWS Length (in)	N/A
N/A	Landing X Slope (%)	N/A	N/A	DWS Full Width?	N/A
N/A	Landing Curb? (Y/N)	N/A	N/A	DWS Offset (in)	N/A
N/A	Shared Landing?	N/A			
N/A	Gutter Ponding?	N/A	N/A	Gutter Slope (%)	N/A
N/A	Gutter Lip Ht (in)	N/A	N/A	Gutter X Slope (%)	N/A
N/A	Painted X Walk1?	No	N/A	Painted X Walk2?	N/A
	X Walk 1 Direction	To S		X Walk 2 Direction	N/A
N/A	X Walk 1 Width (in)	N/A	N/A	X Walk 2 Width (in)	N/A
	X Walk 1 Slope (%)	5.4		X Walk 2 Slope (%)	N/A
	X Walk 1 X Slope (%)	1.3		X Walk 2 X Slope (%)	N/A

N/A	Ramp inside XWalk1?	N/A	N/A	Ramp inside XWalk2?	N/A
	Road Slope (%)	N/A	N/A	Clear Space?	N/A
	Road X Slope (%)	N/A	N/A	Clear Space to XWalk (in)	N/A
N/A	Any Obstructions?	N/A	N/A	Storm Grate/Utility Hazard?	N/A
	Obstruction Type			Storm Grate/Utility Type	
		N/A			N/A
			Yes	Surface Condition? (G/P)	Good

Possible Solutions:

Remove & Replace Entire Ramp.

R304.2.2
