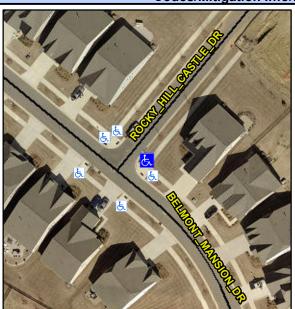
Intersection ID: 54324 Main Street: BELMONT MANSION DR Cross Street: ROCKY\_HILL\_CASTLE\_DR Location: NE ADA ID: BACDFB959790 Ramp Type: BlendTrans1 Initial Pass/Fail: Fail **Overall Compliance: No Severity Score:** 8.75

Field Measurements/Component Compliance					
Compliance Description		Data	Comp	liance Description	Data
N/A	Ramp Length (in)	115.0	Yes	BlendTrans Slope (%)	1.7
No	Ramp Width (in)	45.0	Yes	BlendTrans XSlope (%)	1.6
N/A	Flare Type LT	N/A	N/A	Flare Type RT	N/A
N/A	Flare Slope LT (%)	N/A	N/A	Flare Slope RT (%)	N/A
N/A	Flare Traversable LT?	N/A	N/A	Flare Traversable RT?	N/A
N/A	Landing Length (in)	N/A	N/A	DWS Provided?	N/A
N/A	Landing Width (in)	N/A	N/A	DWS Contrast?	N/A
N/A	Landing Slope (%)	N/A	N/A	DWS Length (in)	N/A
N/A	Landing X Slope (%)	N/A	N/A	DWS Full Width?	N/A
N/A	Landing Curb? (Y/N)	N/A	N/A	DWS Offset (in)	N/A
N/A	Shared Landing?	N/A			
N/A	Gutter Ponding?	N/A	N/A	Gutter Slope (%)	N/A
N/A	Gutter Lip Ht (in)	0.5	N/A	Gutter X Slope (%)	N/A
N/A	Painted X Walk1?	No	N/A	Painted X Walk2?	N/A
	X Walk 1 Direction	To NW		X Walk 2 Direction	N/A
	X Walk 1 Width (in)	N/A		X Walk 2 Width (in)	N/A
	X Walk 1 Slope (%)	2.1		X Walk 2 Slope (%)	N/A

X Walk 1 X Slope (%)	4.2		X Walk 2 X Slope (%)	N/A
N/A	Ramp inside XWalk1?	N/A	N/A	Ramp inside XWalk2?	N/A
	Road Slope (%)	4.2		Clear Space?	N/A
	Road X Slope (%)	2.1	N/A	Clear Space to XWalk (in)	N/A
N/A	Any Obstructions?	N/A	N/A	Storm Grate/Utility Hazard?	N/A
	Obstruction Type		l	Storm Grate/Utility Type	
		N/A	l		N/A
			Yes	Surface Condition? (G/P)	Good
			N/A	Curb Slope (%)	2.3

Street 1 Name Stop Condition-Street 1 Street 2 Name Stop Condition-Street 2 **Remove & Replace Curb Ramp With Two New Directional Ramps or** Equivalent.

R304.5.1
